# Repairability of AHSS: Zinc Removal and Hole Size Study

**Justin Hunt**

Stellantis

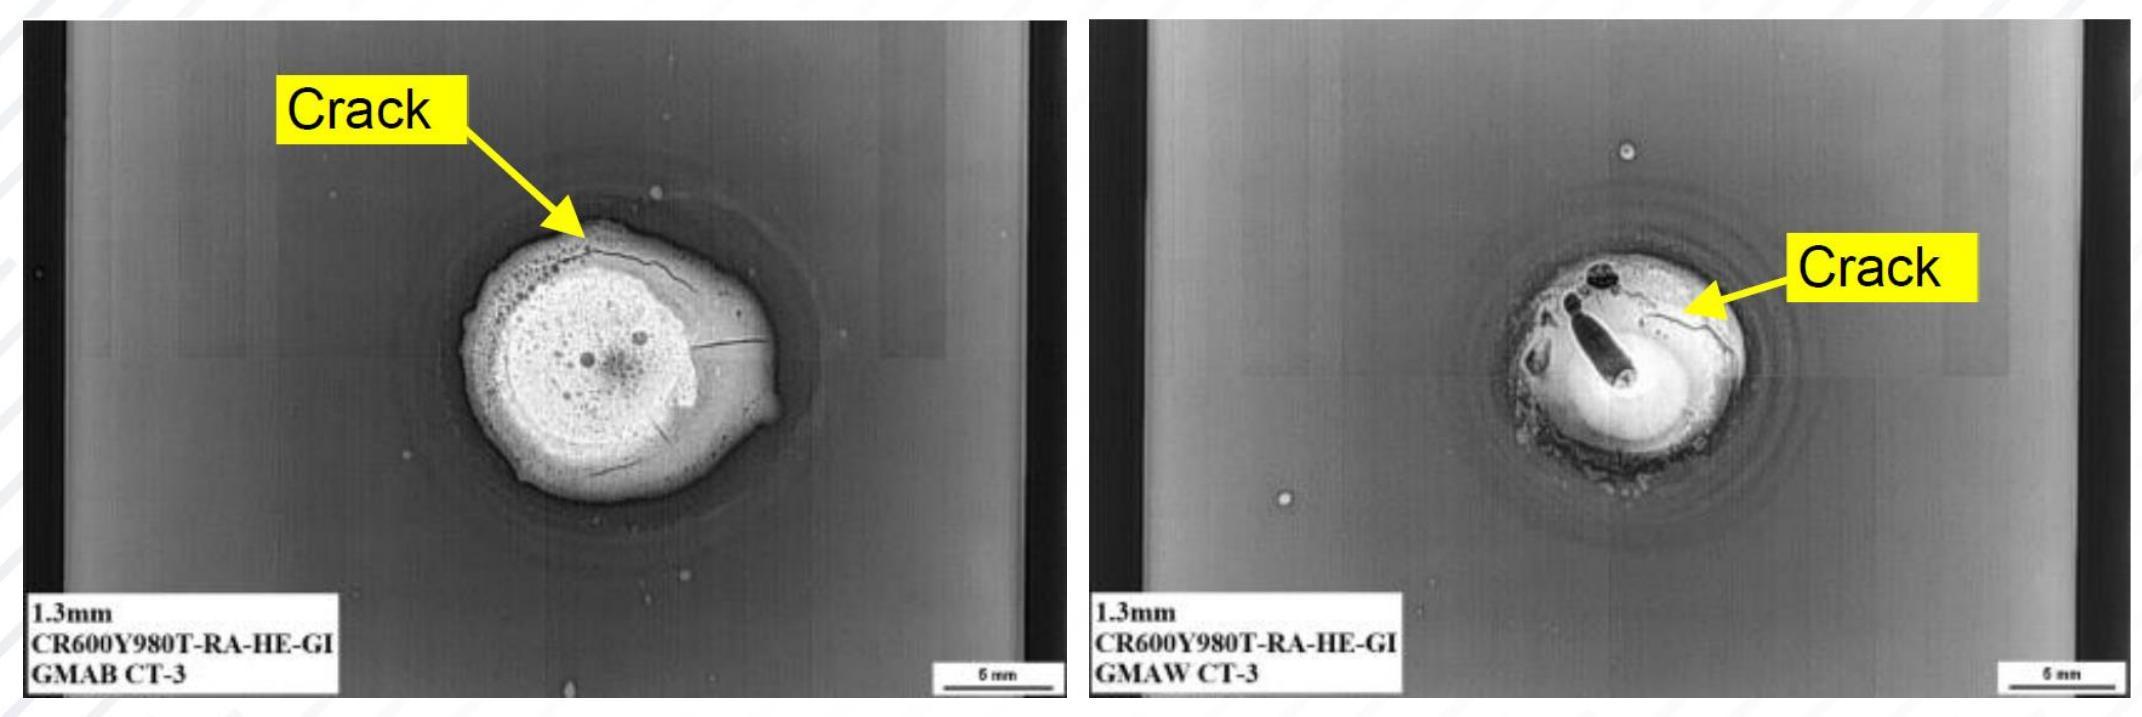
1.3 mm CR600Y980T-RA-HE-GI (Lot 192) GMAB Plug (8 mm Hole ERCuSi-A) Cracks present in 6 of 6 samples 1.3 mm CR600Y980T-RA-HE-GI (Lot 192) GMAW Plug (8 mm Hole ER120S-G) Cracks present in 5 of 6 samples

Project #5 GMAB and GMAW plug joints exhibited "internal" cracking believed to be LME.

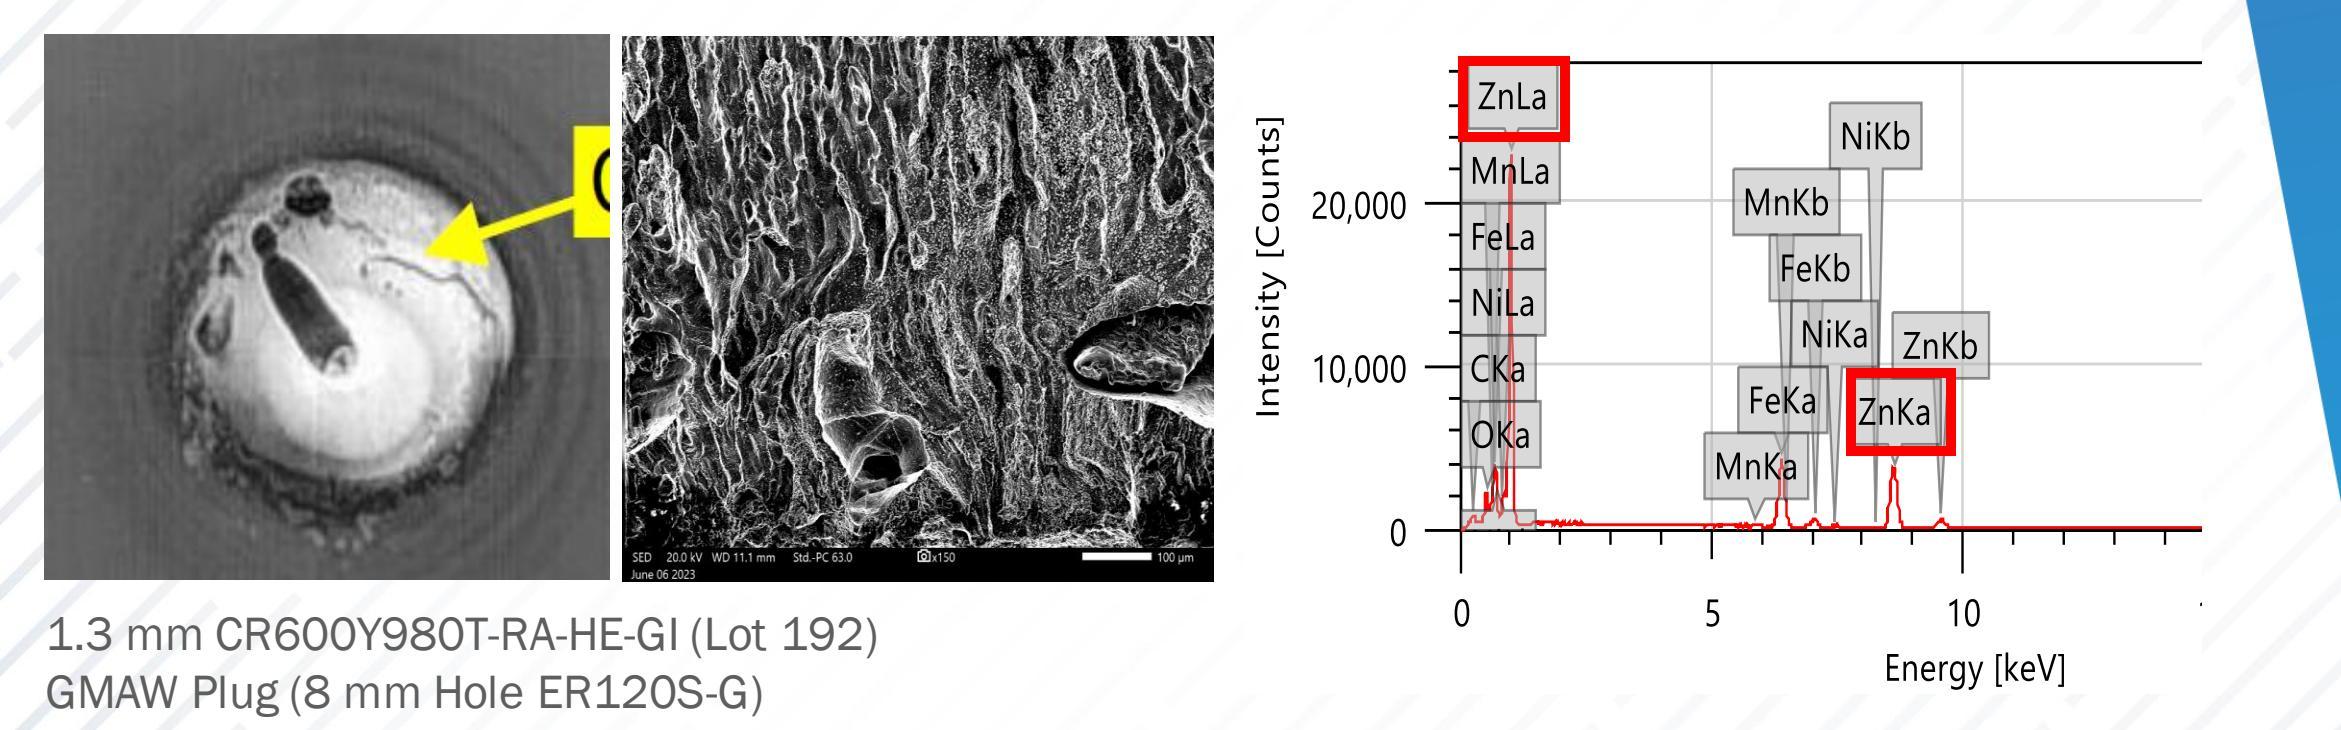
The Project #5 sample evaluated had zinc on the fracture surface, indicating potential LME.

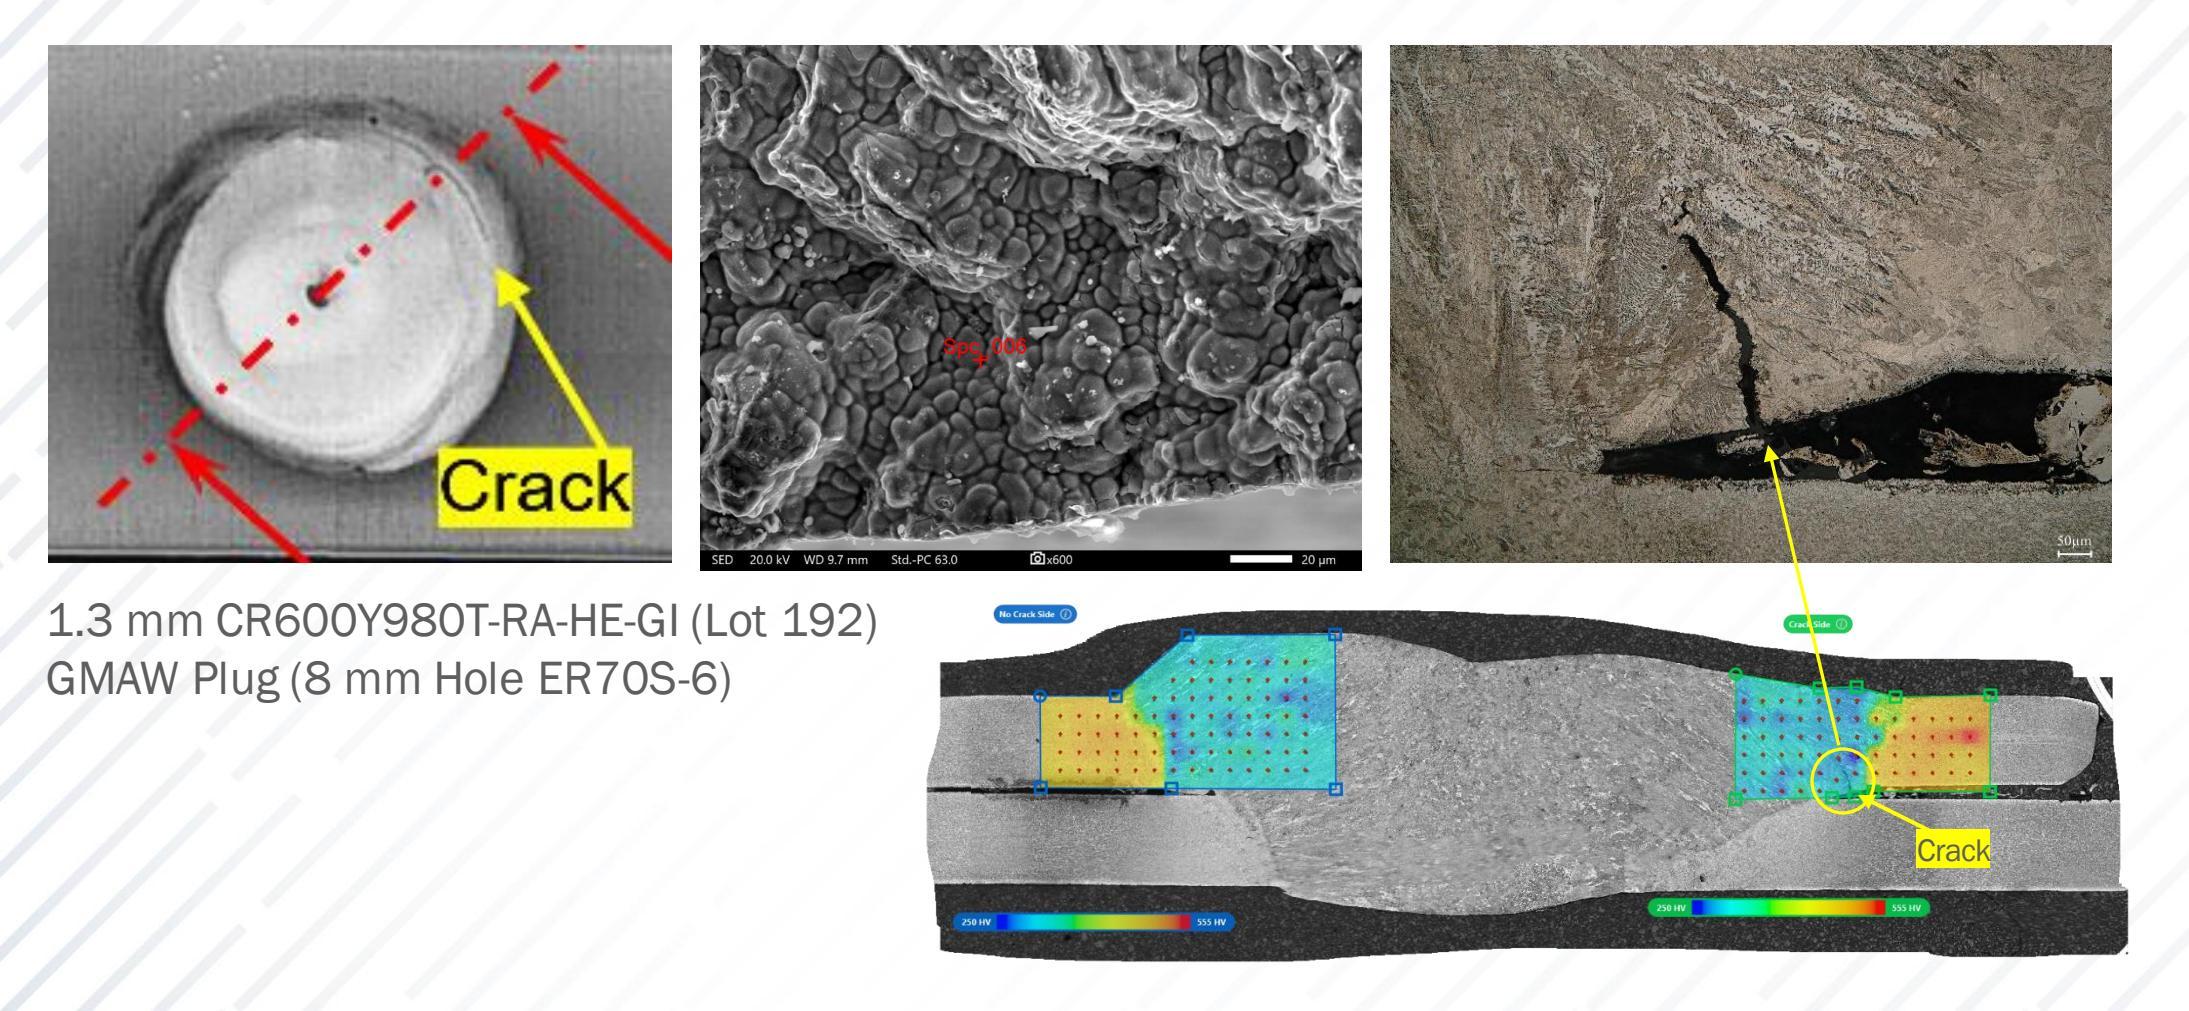
The Project #6 sample evaluated exhibited a crack in the weld metal with no zinc detected on the fracture surface. Dendritic structures were observed on the fracture surface. This is characteristic of hot cracking occurring during solidification, unrelated to LME.

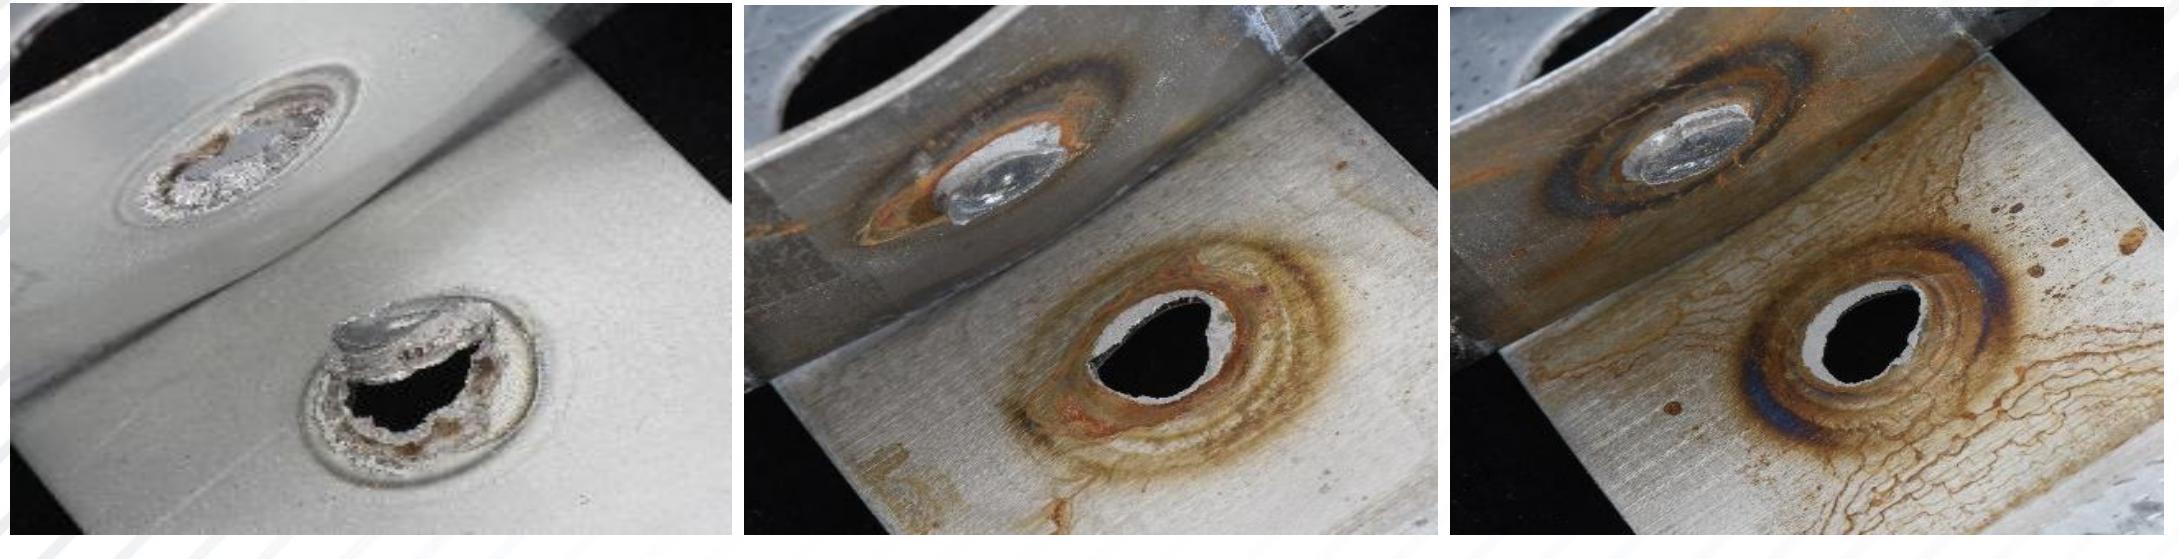
"All zinc"

"Bottom side zinc"

"No zinc"

Evidence of porosity is observed on the "all zinc" fracture surface which may have reduced peak loads.

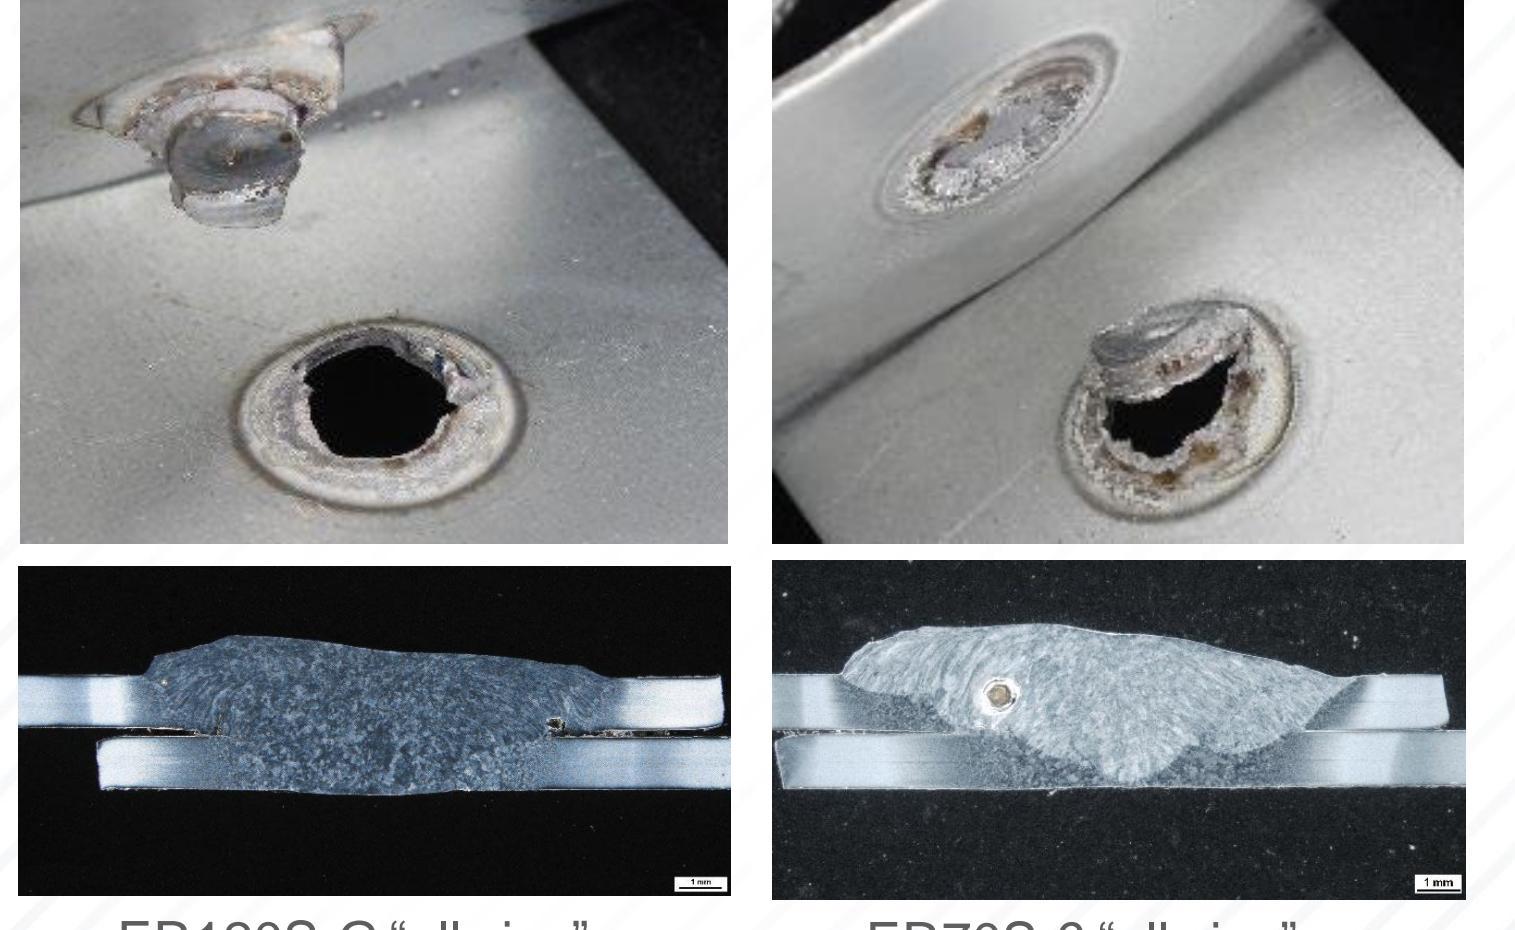
ER120S-G "all zinc"

ER70S-6 "all zinc"

ER120S-G joints were typically higher strength than ER70S-6 joints
