# REPAIRABILITY of 3rd GEN AHSS

Justin Hunt  
Stellantis

The objective of A/SP Repairability of AHSS projects is to obtain weld joint repair data to assist automotive OEMs and the collision repair industry in developing appropriate weld joint repair strategies for 3<sup>rd</sup> Gen AHSS. These steels have unique mechanical properties and weldability characteristics that may result in the need for updated weld repair strategies.

This presentation includes supplemental data to support the comprehensive work performed in previous A/SP Repairability of AHSS projects P#1 through P#6. The specific objectives of P#7 include the following:

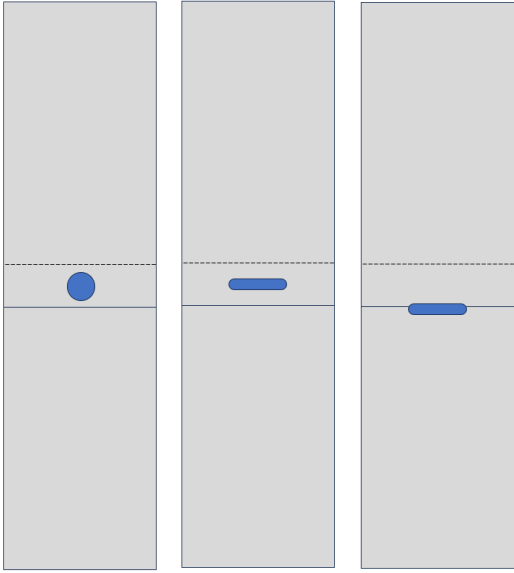
## SHEAR TENSION

RSW (Production and Service)  
GMAB Plug 8 mm Hole  
GMAW Plug 8 mm Hole  
Manual Laser - 20 mm Lap  
Manual Laser - 20 mm Lap Fillet  
Rivet

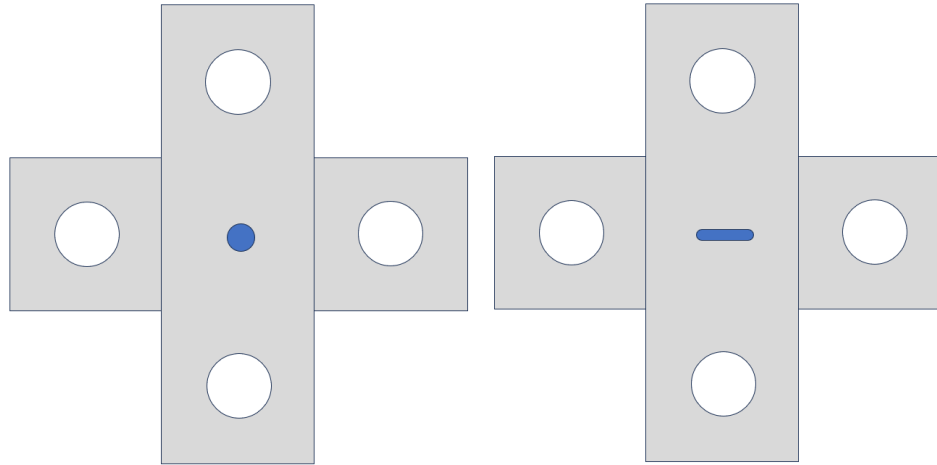
## CROSS TENSION

RSW (Production and Service)  
GMAB Plug 8 mm Hole  
GMAW Plug 8 mm Hole  
Manual Laser - 20 mm Lap  
Rivet

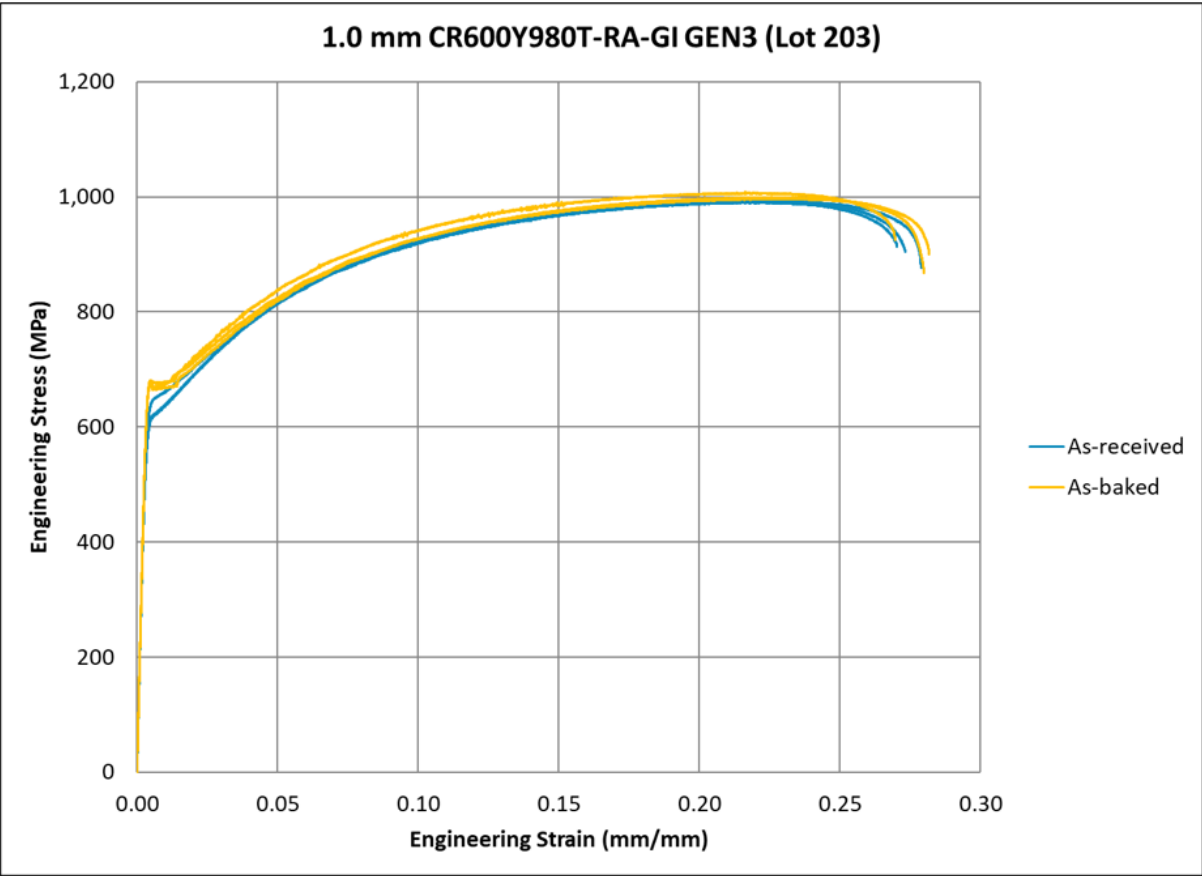
# BASE METAL STRESS-STRAIN CURVES

- The material tested meets minimum mechanical property requirements.
- A 7% increase in yield strength was observed after paint bake cycle.

Specimen ID	Ultimate Tensile Strength (MPa)	Yield Strength 0.2% offset (MPa)	Elongation (%)
As-received 1	991	618	27.1
As-received 2	994	615	27.9
As-received 3	992	645	28.4
As-baked 1	1008	669	28.4
As-baked 2	997	676	28.8
As-baked 3	1000	667	28.2

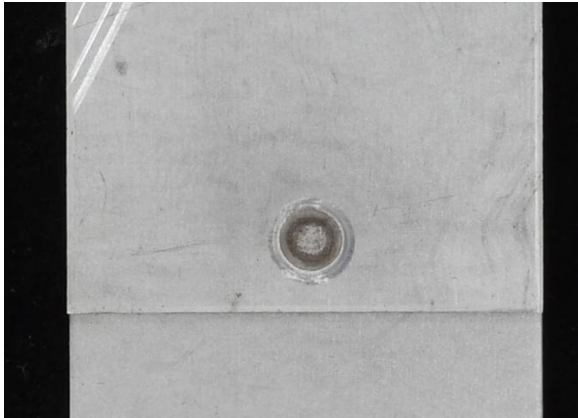
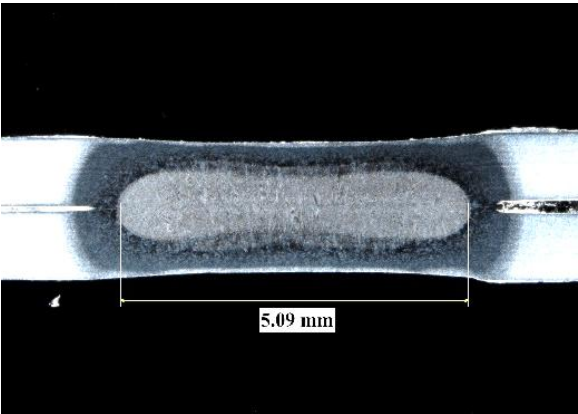
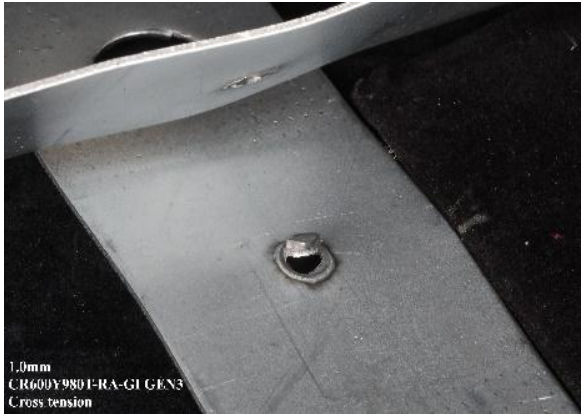
RSW PRODUCTION

- Production RSW joints referencing AWS D8.9M welding schedule
- Service RSW joints were made using Pro Spot i5 welder, in automatic mode (no welding parameter adjustment)
- Targeted weld size was 5.0 mm for RSW production joints

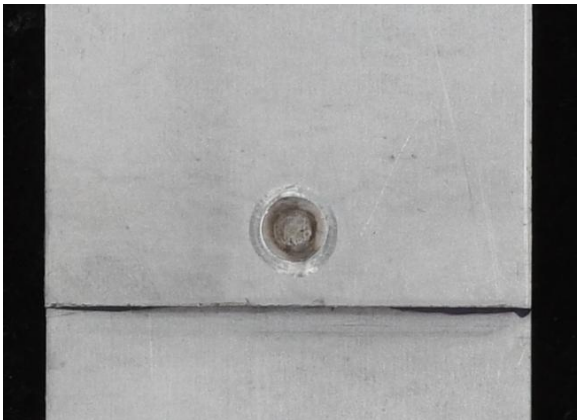
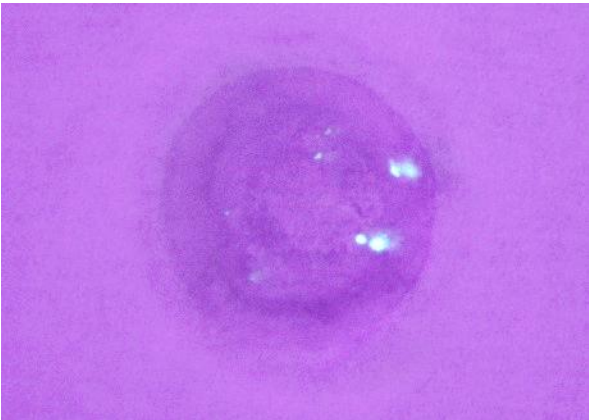
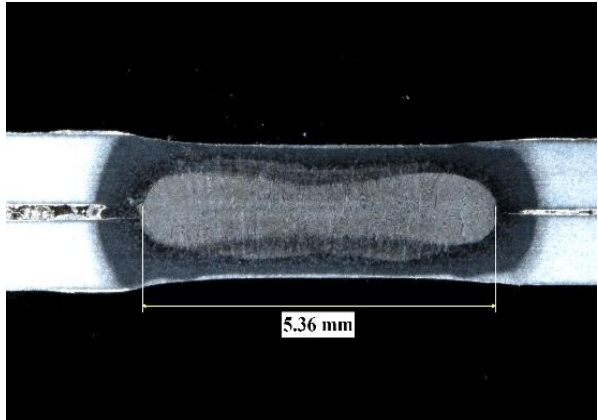
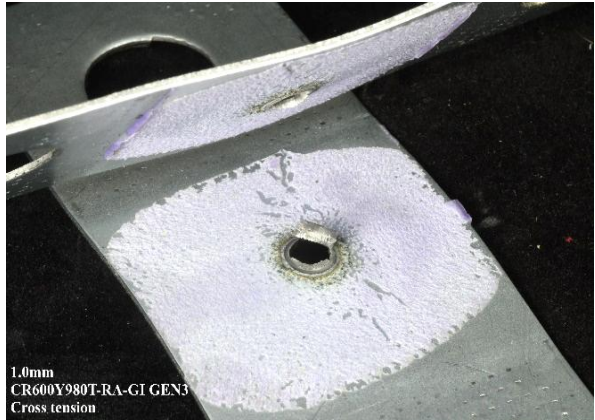
RSW PRODUCTION WITH ADHESIVE

FLPI indications were not attributed to LME cracking.

Button pull with cohesive separation

- Production adhesive: Henkel Teroson EP 5089 (Cured for 20 minutes at 170°C)
- Service adhesive: Henkel Teroson EP 5065 (cured for 48 hours at room temperature)
- 3.0 mm diameter adhesive bead applied across the width of coupons

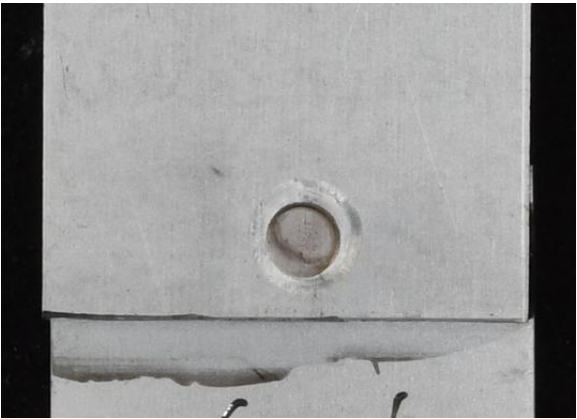
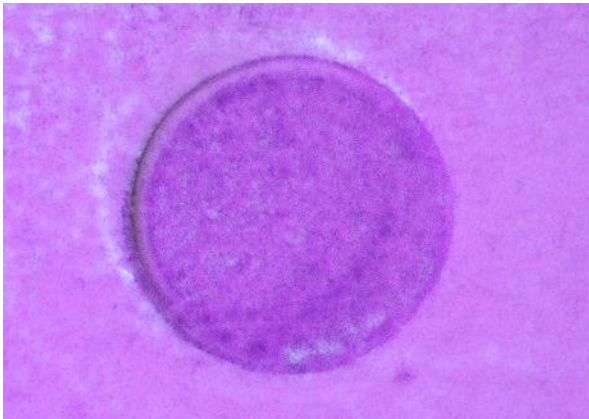
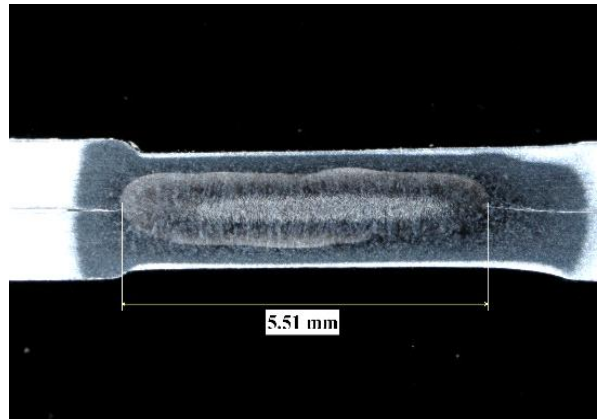
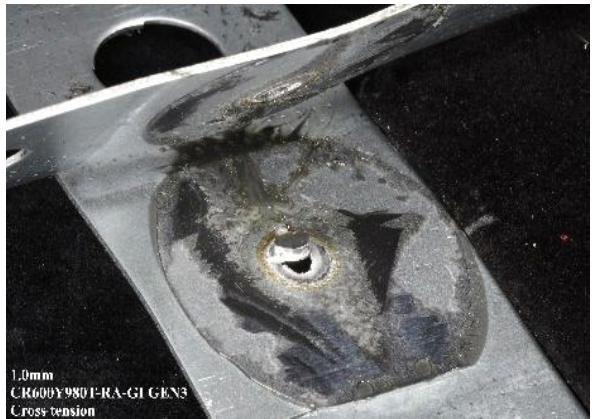
RSW SERVICE WITH ADHESIVE

Button pull with adhesive separation

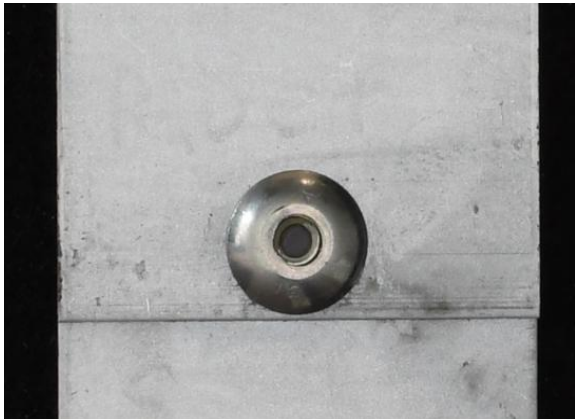
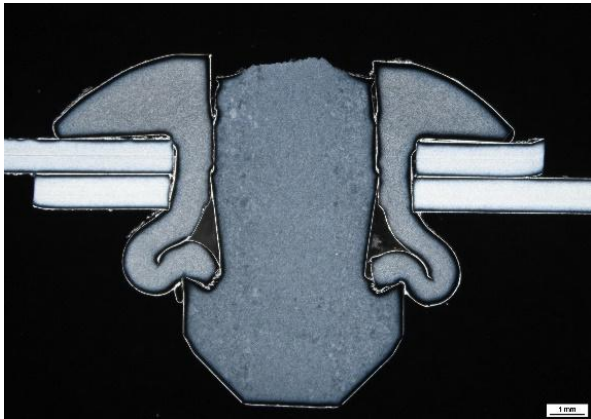
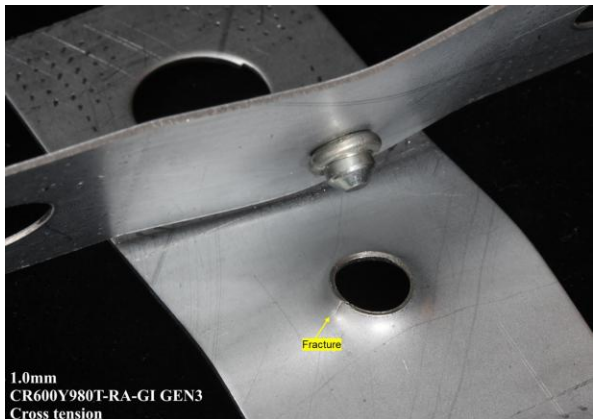
RIVET

- 6.4 mm diameter Hemlok Rivet 02221-00812
- 6.7mm diameter hole

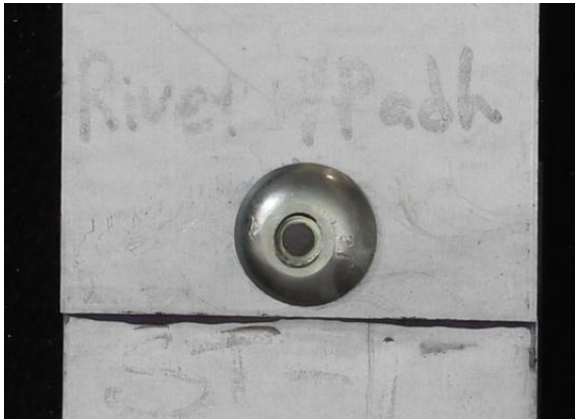
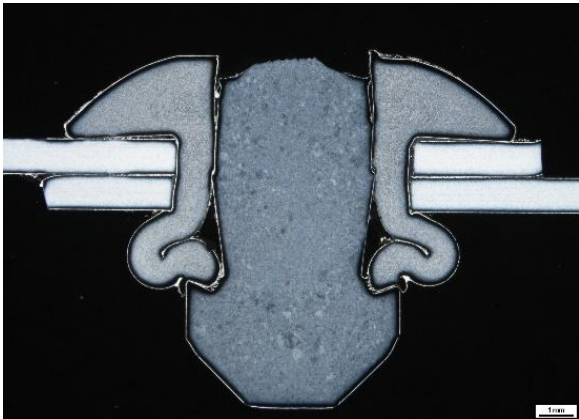
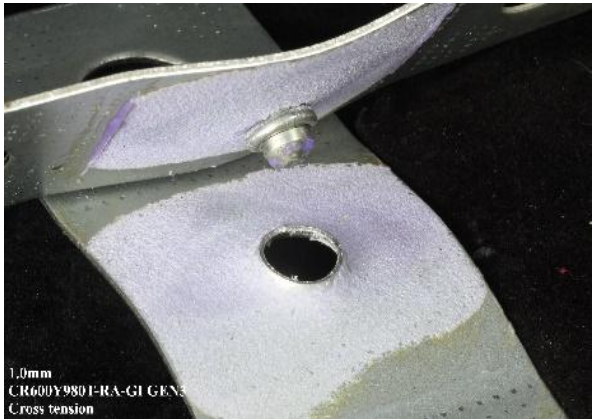
RIVET WITH  
PRODUCTION ADHESIVE

Rivet pull-out with cohesive fracture

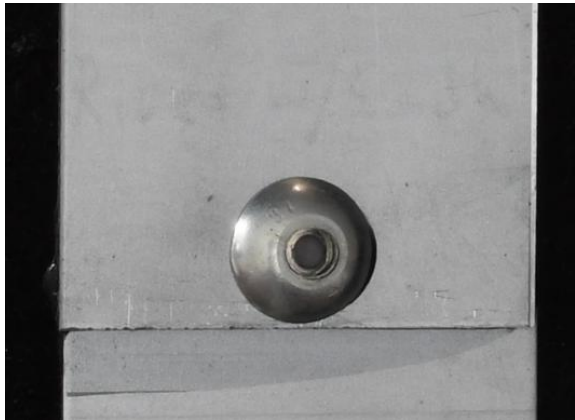
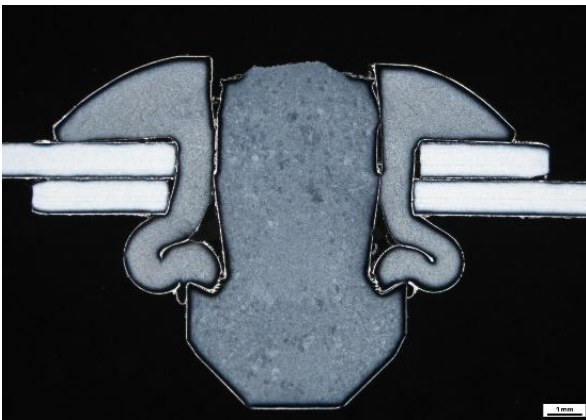
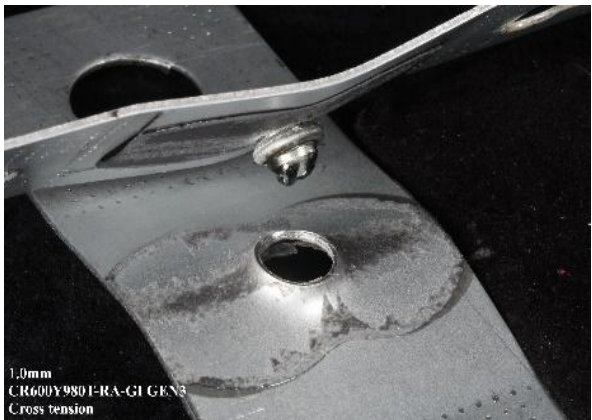
RIVET WITH SERVICE  
ADHESIVE

Rivet pull-out with adhesive fracture

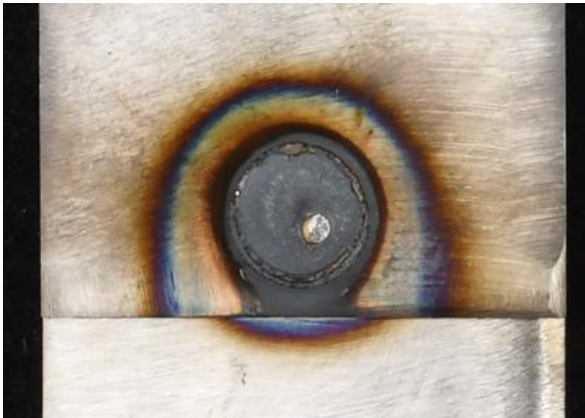
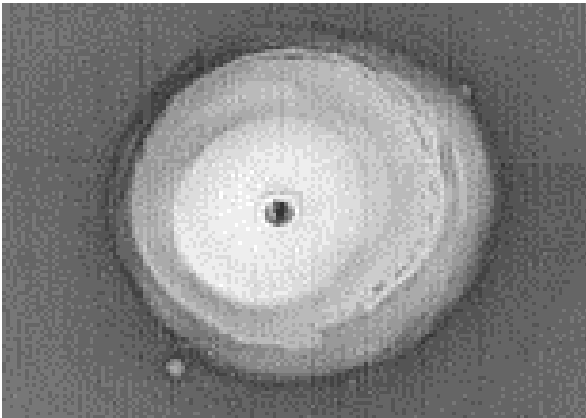
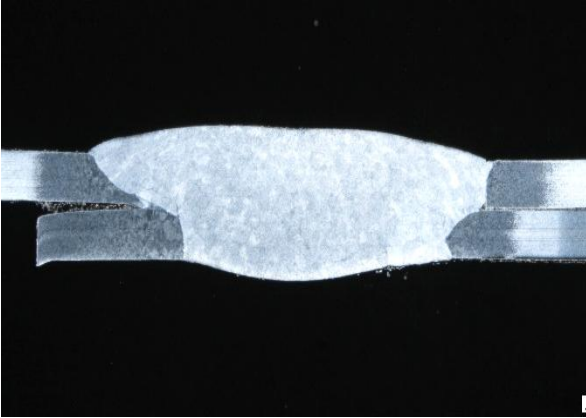
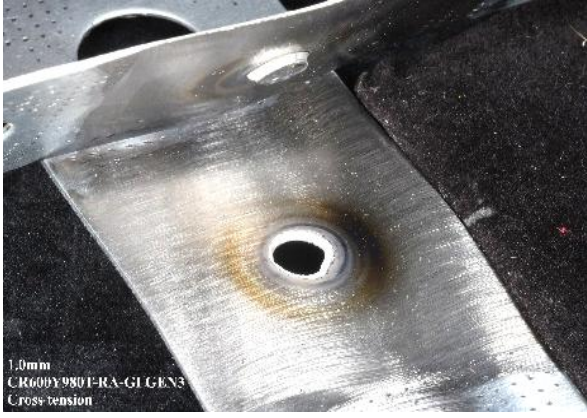
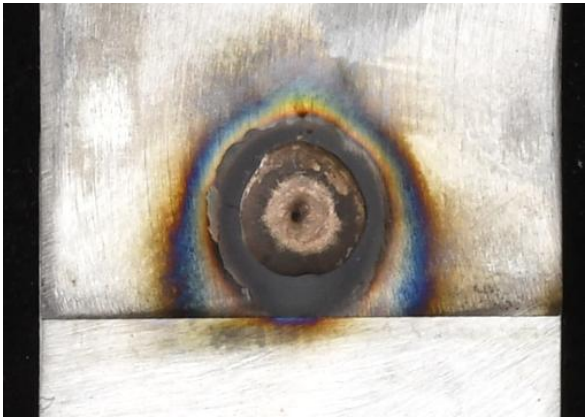
**GMAW PLUG**

- 8 mm diameter hole, top sheet
- 0.9 mm ER70S-6 filler wire with 90% Argon 10% CO<sub>2</sub> shielding gas
- Zinc removed from both sides of top coupon and the faying surface of the bottom coupon prior to welding.

- Manual removal of zinc coating at the GMAW plug and GMAB plug joints prior to welding appeared to mitigate LME cracking.
- LME cracking was not detected in any of the test samples.
- The RSW production with adhesive process produced higher joint strength than the RSW or rivet processes with service adhesive.
- Manual laser process produced the highest joint strengths of all processes without adhesive.
- For the material evaluated in this project, repair processes can be selected that meet or exceed the joint strength of the baseline RSW production process.
- Project results can be used to assist OEMs in defining appropriate weld joint repair strategies for 980 3<sup>rd</sup> GEN AHSS.
- Common procedures used in this study allow for comparison to other A/SP Joining projects and with prior Repairability Team testing of other AHSS grades and thicknesses.

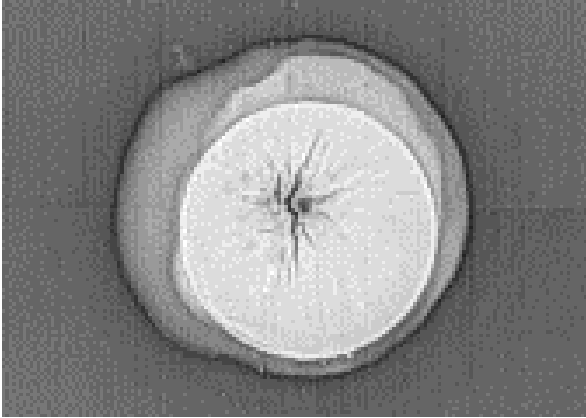
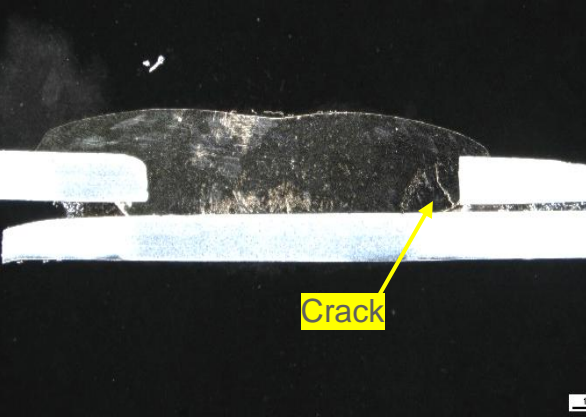
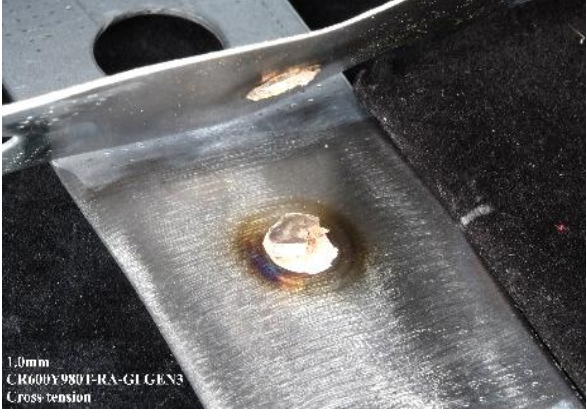
**GMAB PLUG**

- 8 mm diameter hole, top sheet
- 1.0 mm ER CuSi-A filler with 100% argon shielding gas
- Zinc removed from both sides of top coupon and the faying surface of the bottom coupon prior to brazing.

GMAB Plug joint cracking was contained within the braze metal.

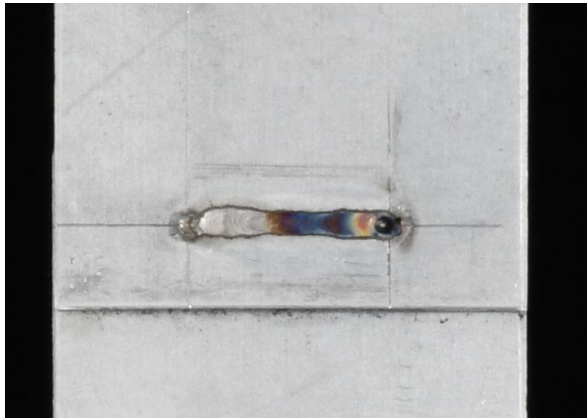
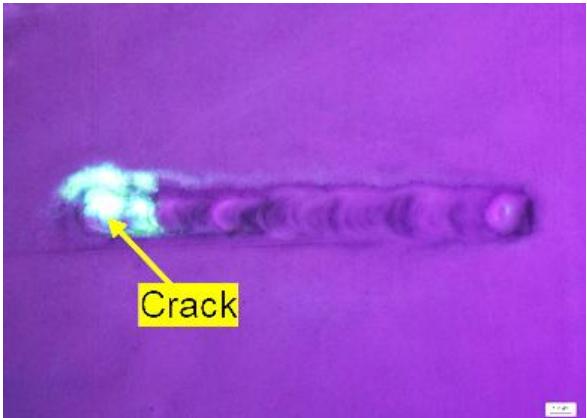
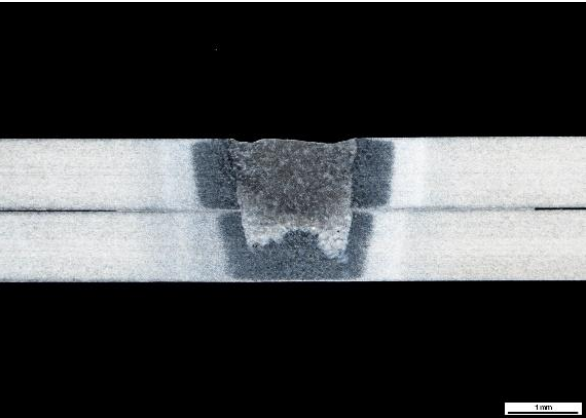
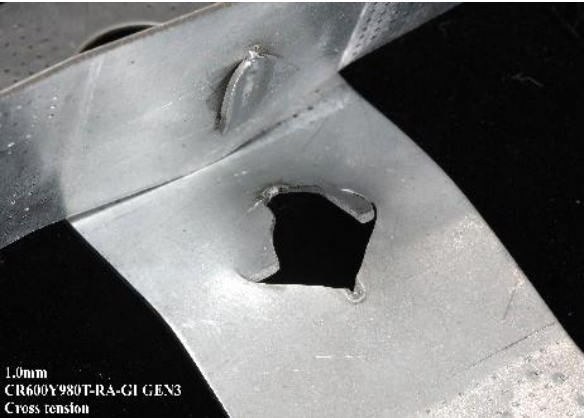
**MANUAL LASER**  
**20 mm LAP**

- Manual laser welded samples were provided by I-Car
- 100% penetration was targeted with visual indication of melt-through on the back side of bottom coupon
- Joints were welded autogenously, without addition of filler metal. Filler metal addition is possible with this process
- 100% nitrogen shielding gas

Weld metal crack mitigation may be possible through welding process adjustment or filler metal addition.

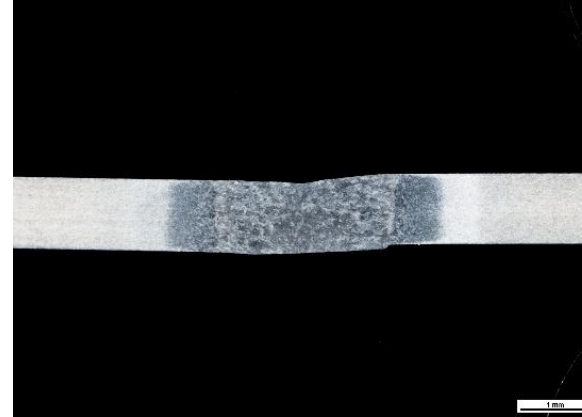
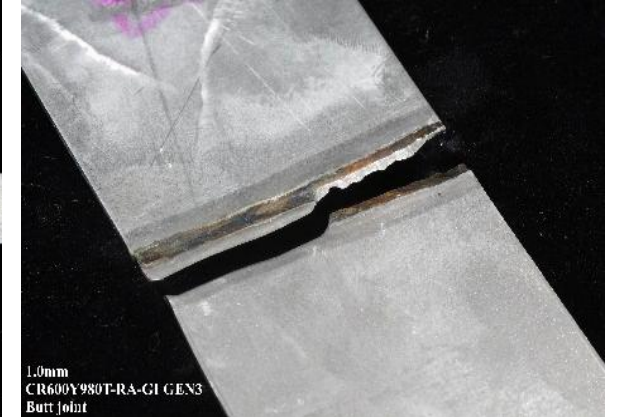
MANUAL LASER  
45 mm BUTT

- Manual laser butt joint tensile strength was approximately 60% to 75% of the base metal tensile strength.
- Process optimization or filler metal addition may be necessary to increase joint strength.

Specimen	Ultimate Tensile Strength (MPa)	Yield Strength 0.2% Offset (MPa)	Elongation (%)
Base Metal - Baked (ASTM E8)	1002	670	28.4
Manual Laser Butt Joint	593 - 746	N/A	N/A

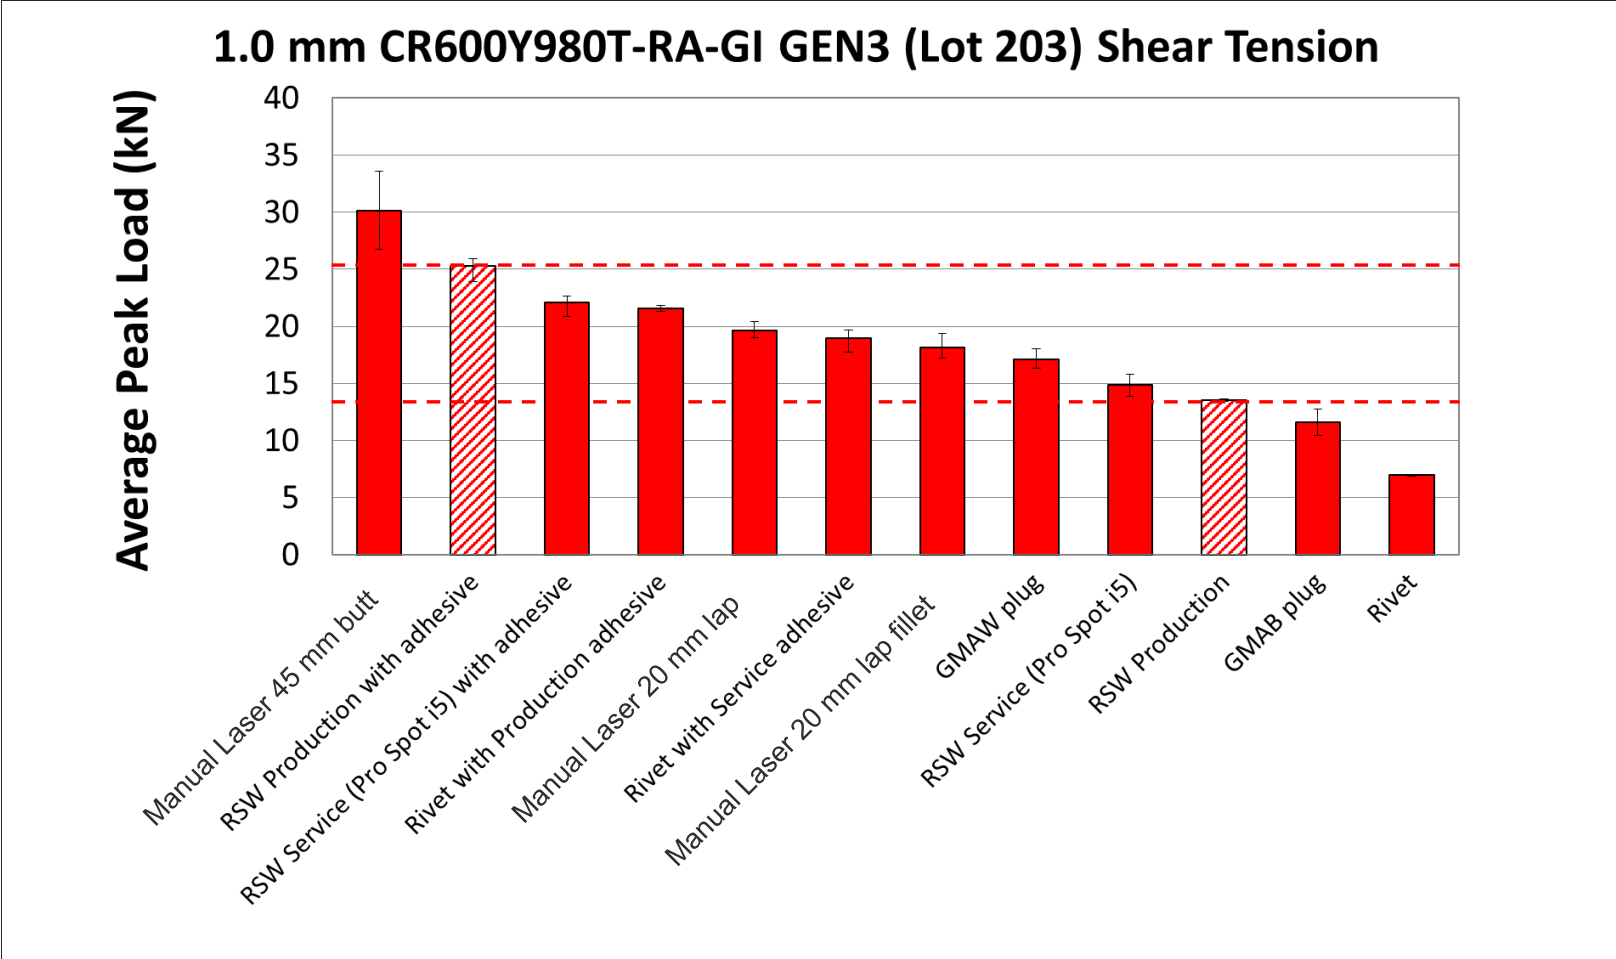
# SHEAR TENSION DATA

- Several repair process options exist that are capable of meeting or exceeding joint strength of the baseline RSW production process.
- The RSW production with adhesive process produced the highest lap joint strength.
- The RSW service with adhesive process produced shear tension joint strength approximately 88% of the RSW production with adhesive process.

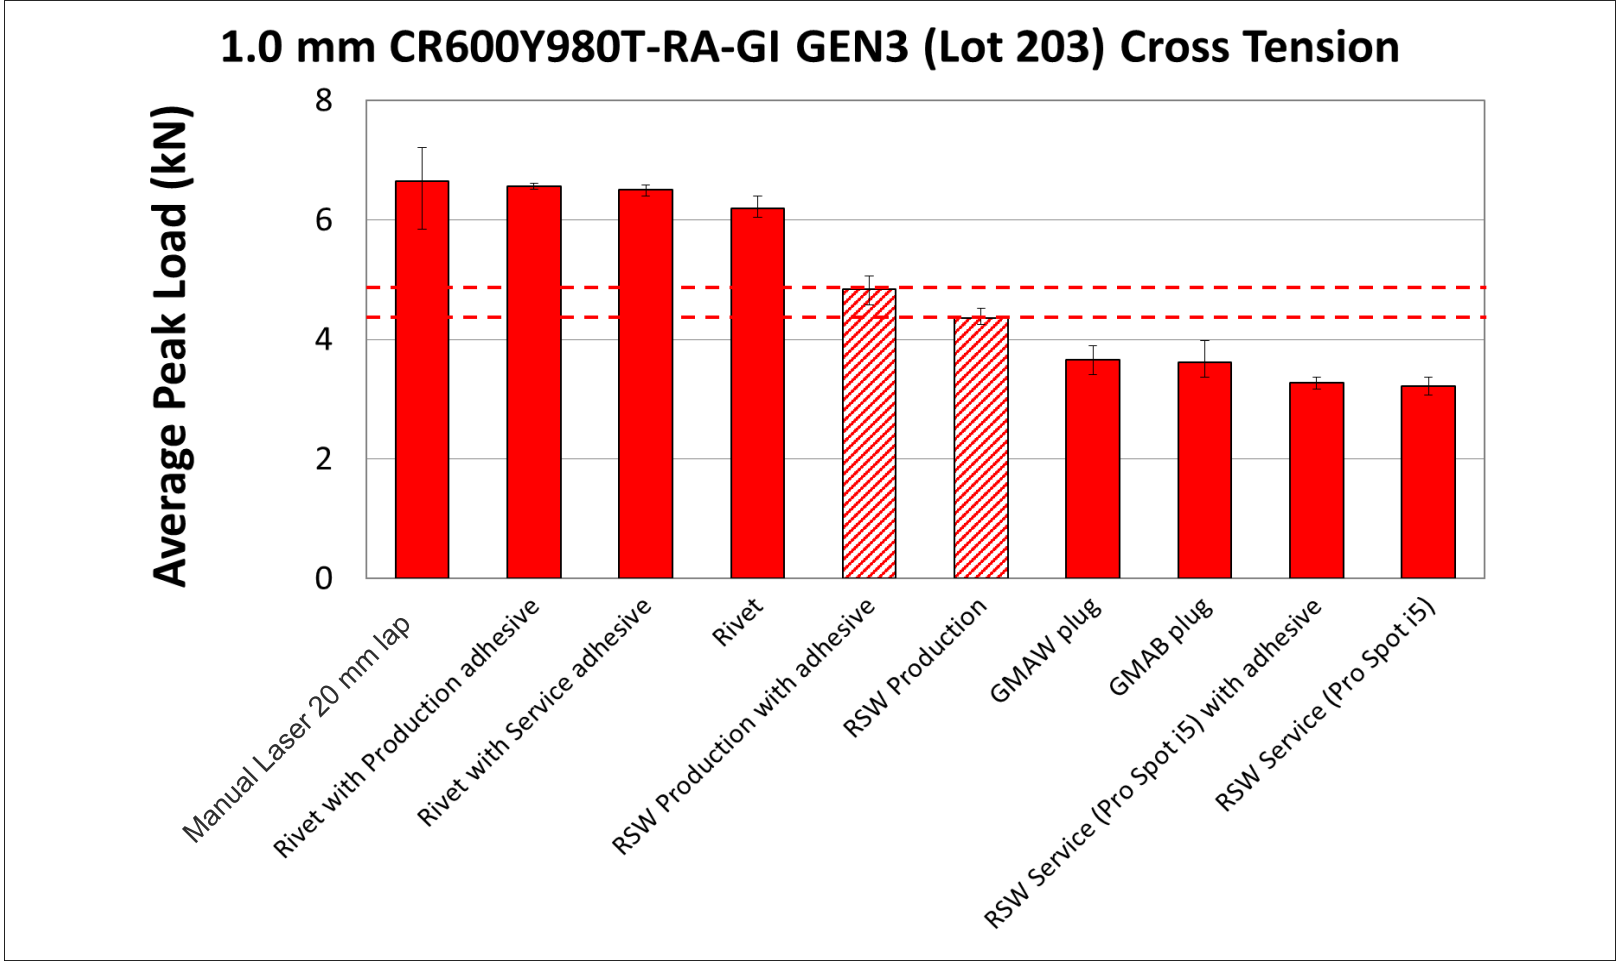
# CROSS TENSION DATA

- Repair process options exist that are capable of meeting or exceeding joint strength of the RSW production process.
- The RSW service with adhesive process produced cross tension joint strength approximately 68% of the RSW production with adhesive process.
