# Repairability of AHSS: Zinc Removal and Hole Size Study

**Justin Hunt**

Stellantis

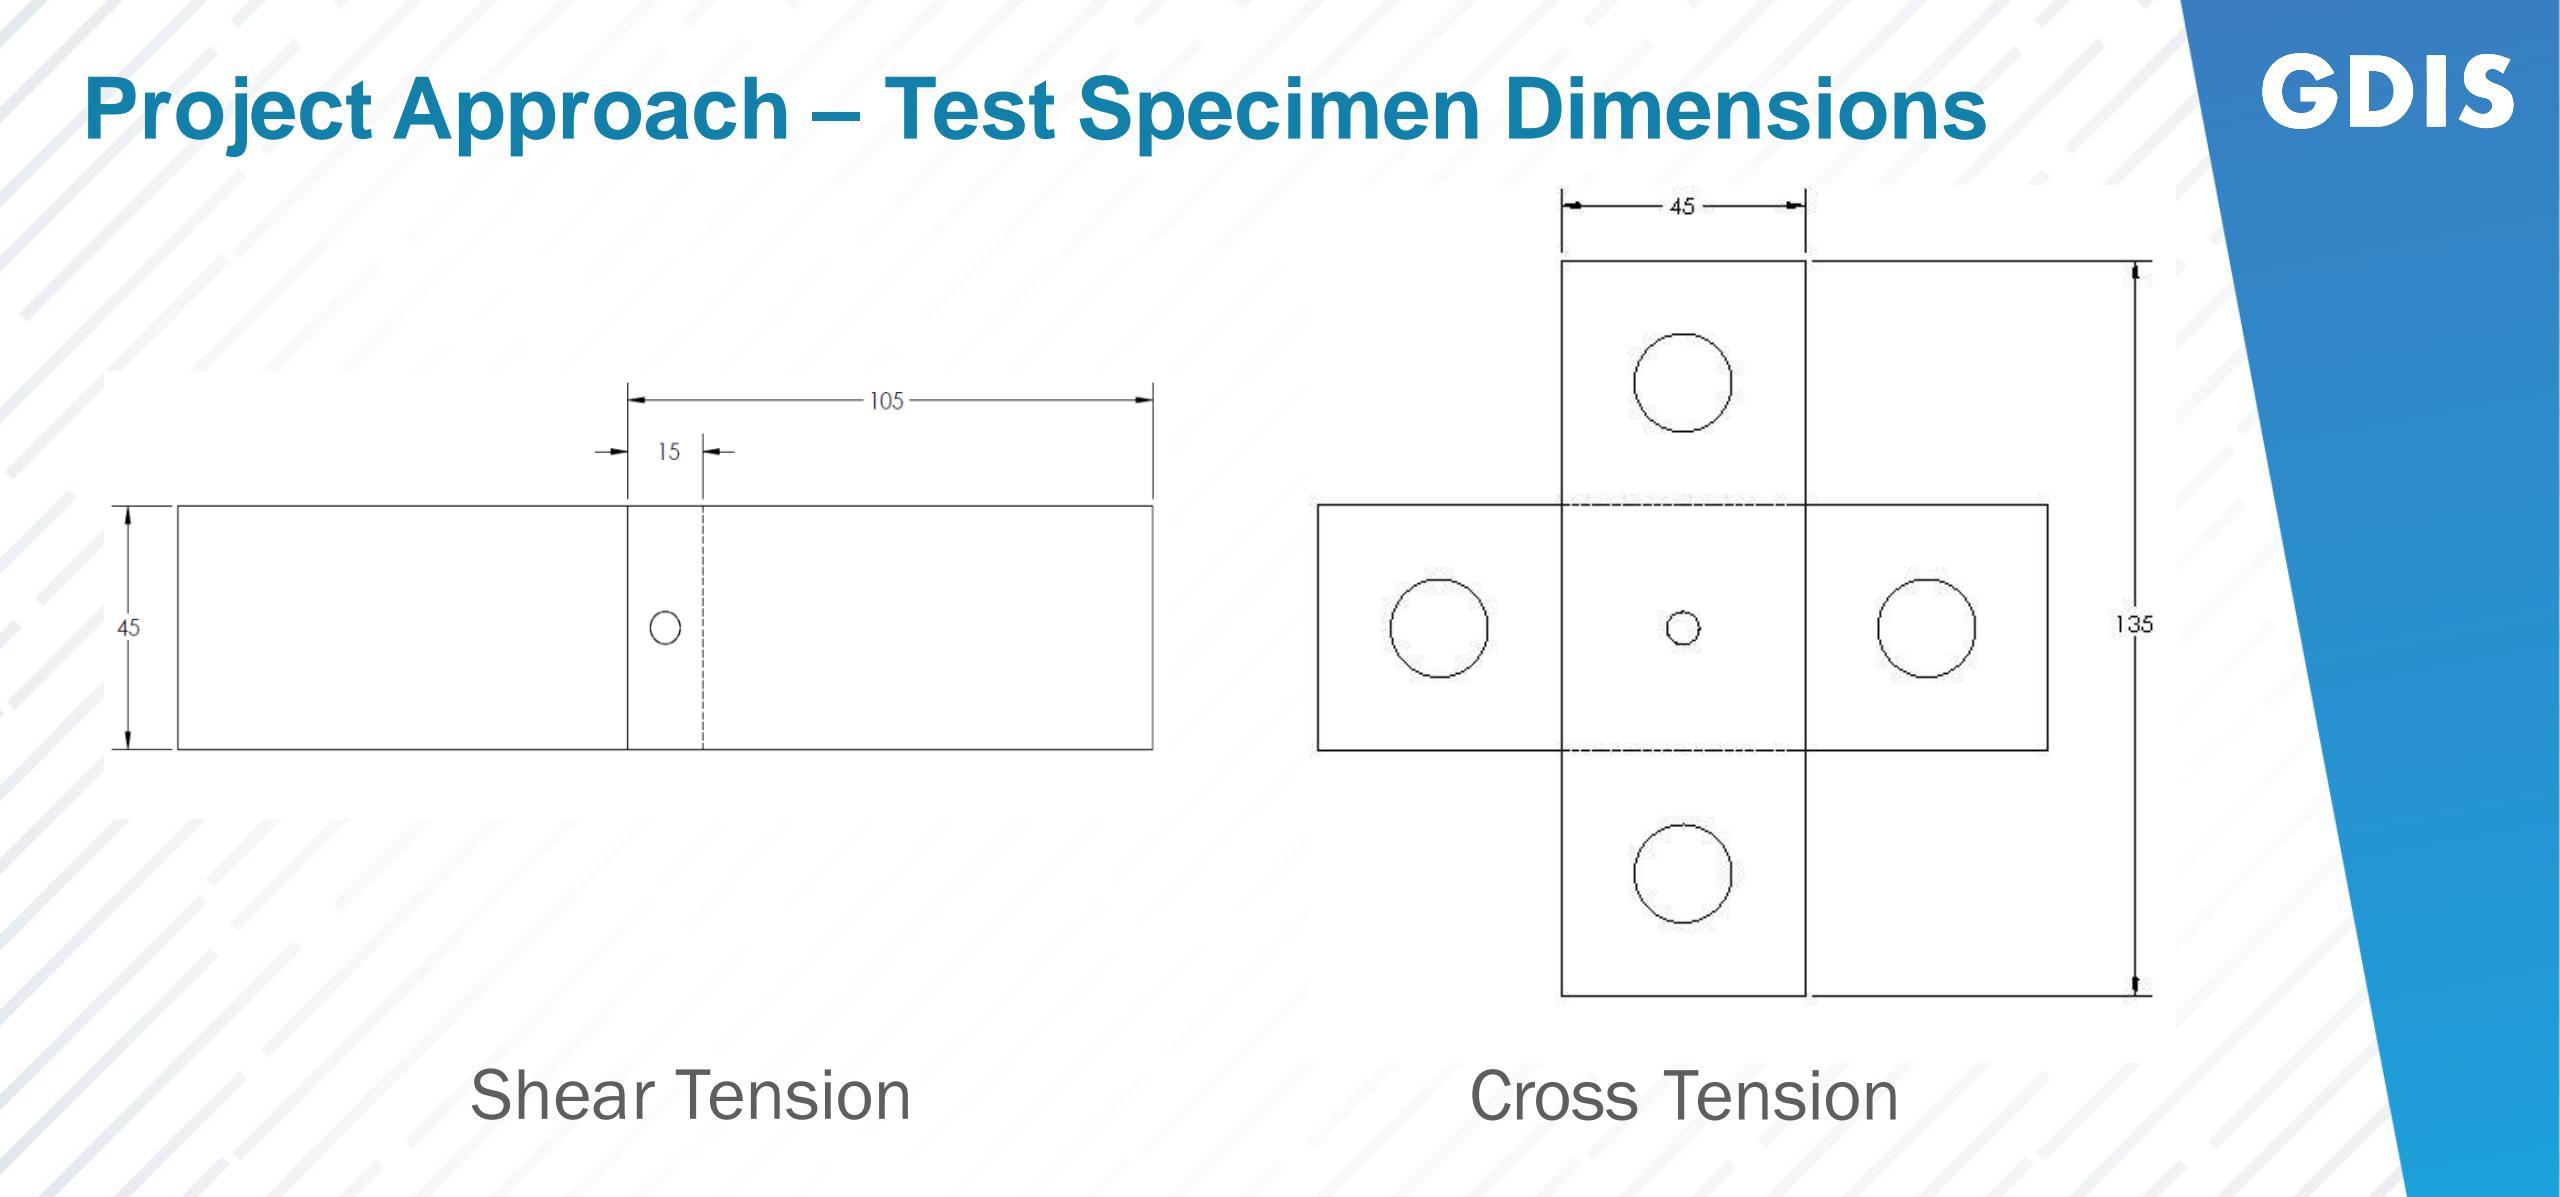
Zinc was ground off the surfaces shown to represent repair scenarios where panel replacement allows zinc removal from the 980 3rd generation steel.

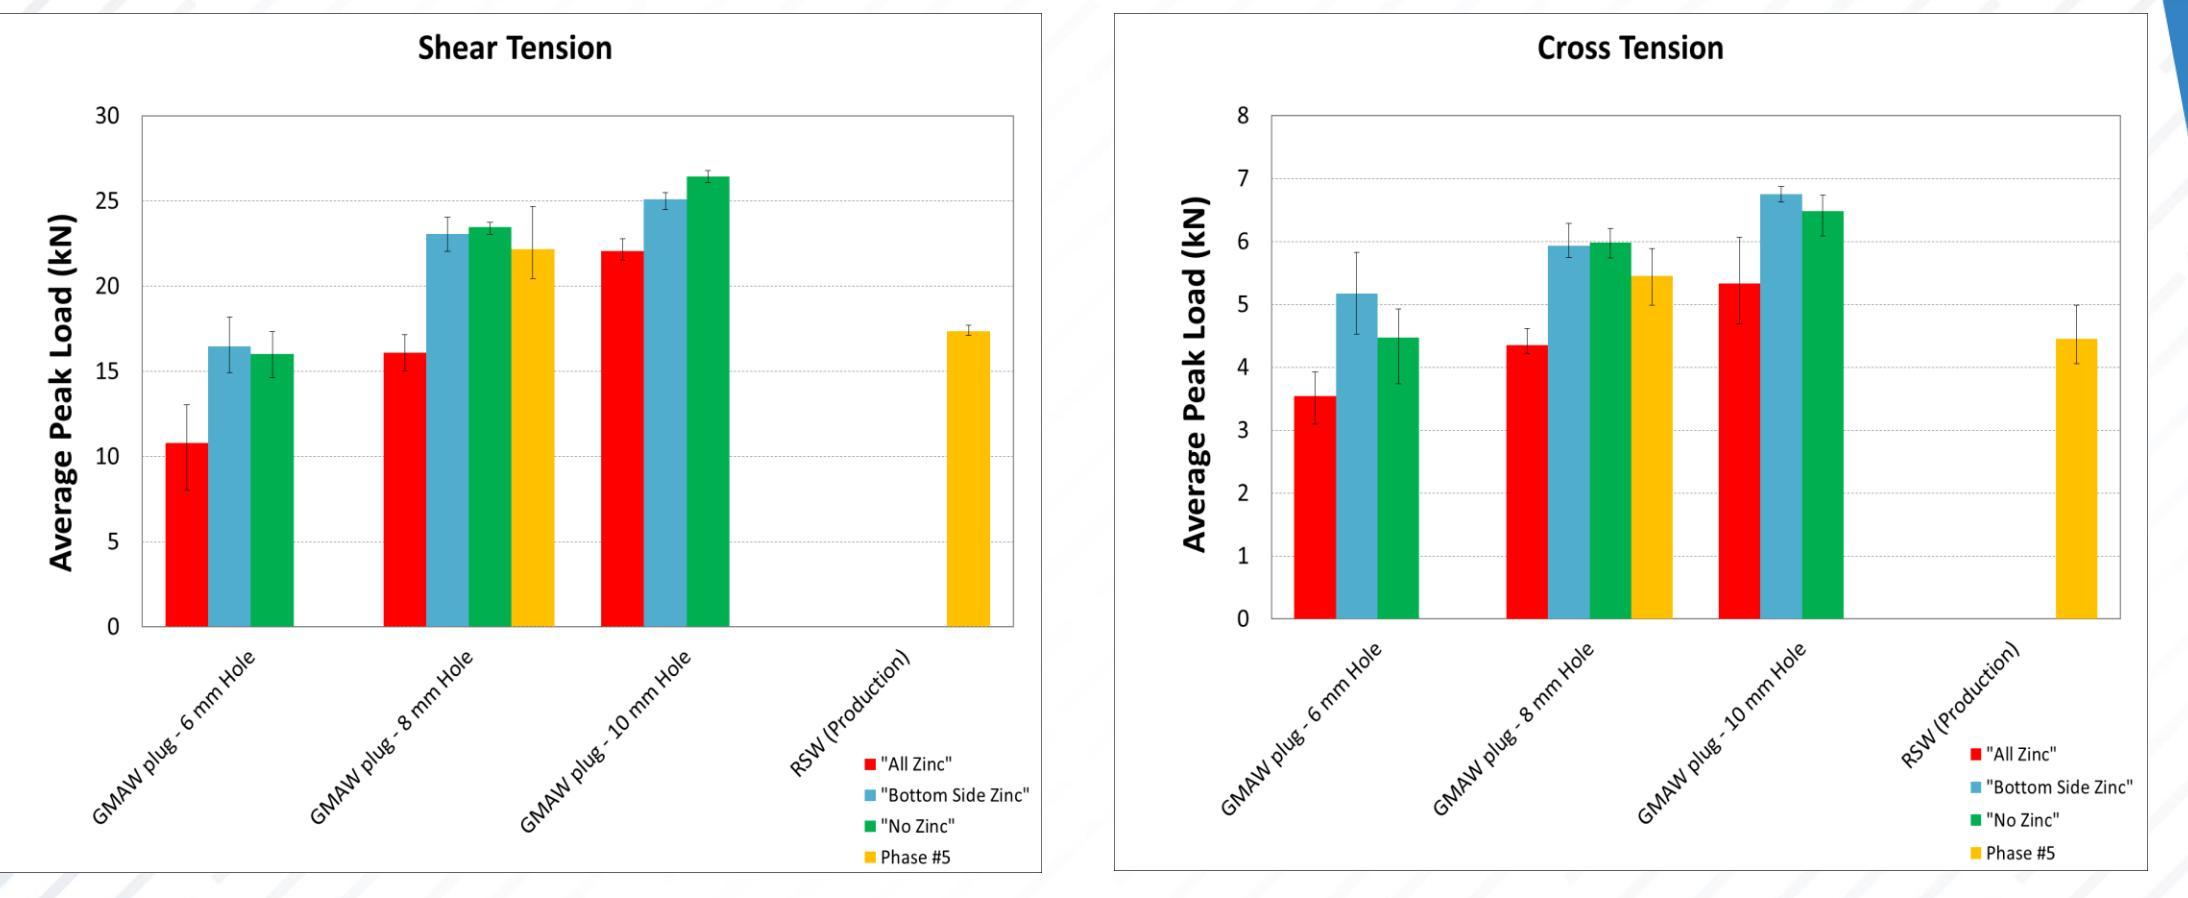
#### Project Results – Average Quasi-static Peak Load

- Peak loads were lower in the "all zinc" surface condition samples. This may be due to the presence of porosity at the fusion boundary.
- Peak loads were higher in the ER120S-G (Phase #5 8 mm hole) samples compared to the ER70S-6 (8 mm hole "all zinc") filler metal samples.
