# Deformation & Edge Stretchability Of Multiphase Steels After Shear Cutting

**Advaith Narayanan**  
*University of Waterloo*

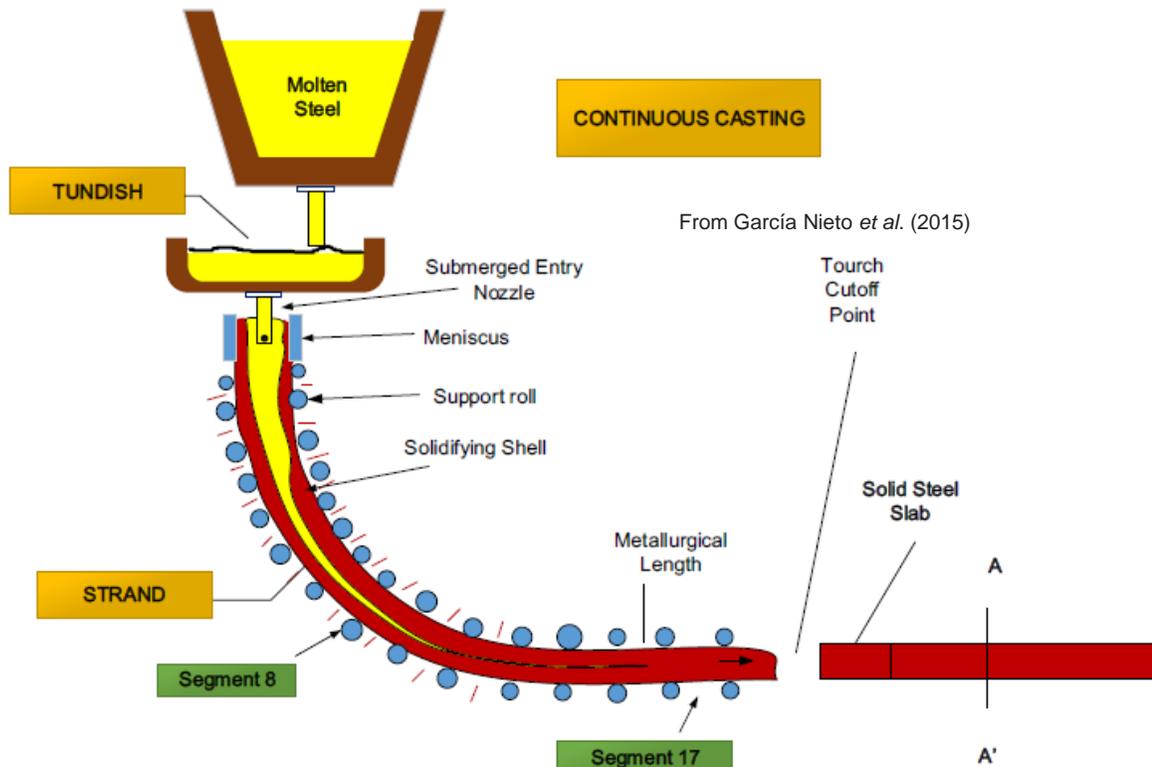
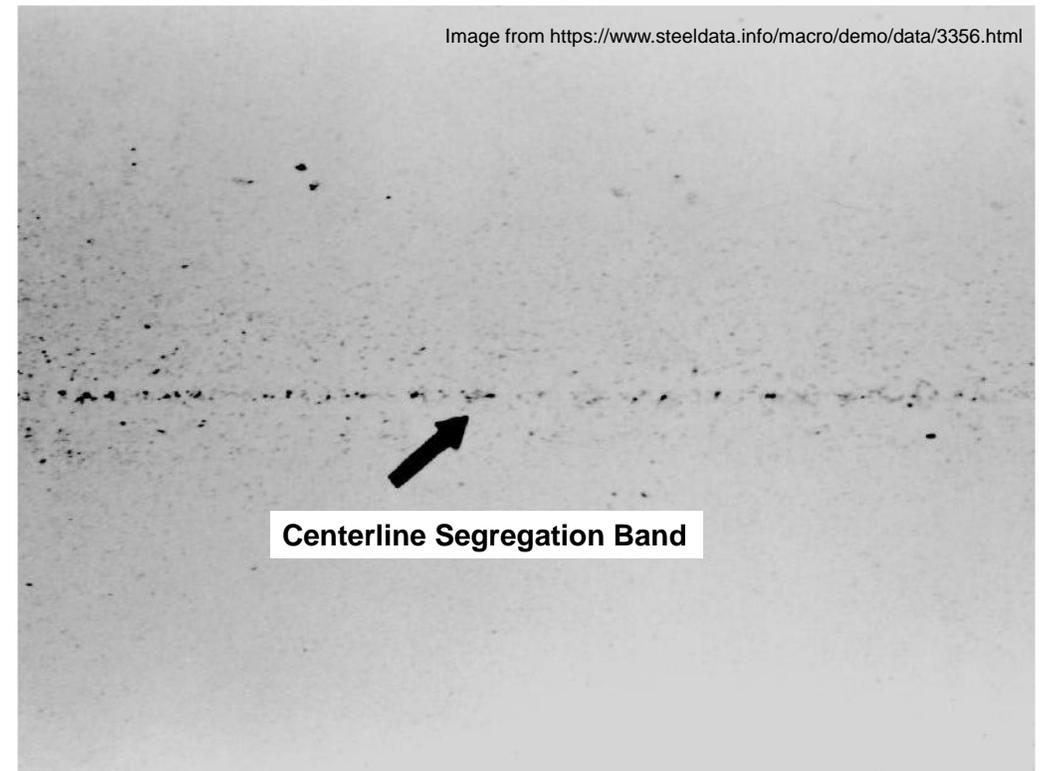
# Introduction: Centerline Segregation in Steels

- Presence and concentration of Ti or Mn-inclusions can occur at mid-thickness in multiphase steels.
- Phenomenon occurs during continuous casting & hot rolling of molten steel containing such alloying elements.
- Higher solidification rate at the surface → alloying elements accumulate near slab mid-thickness.

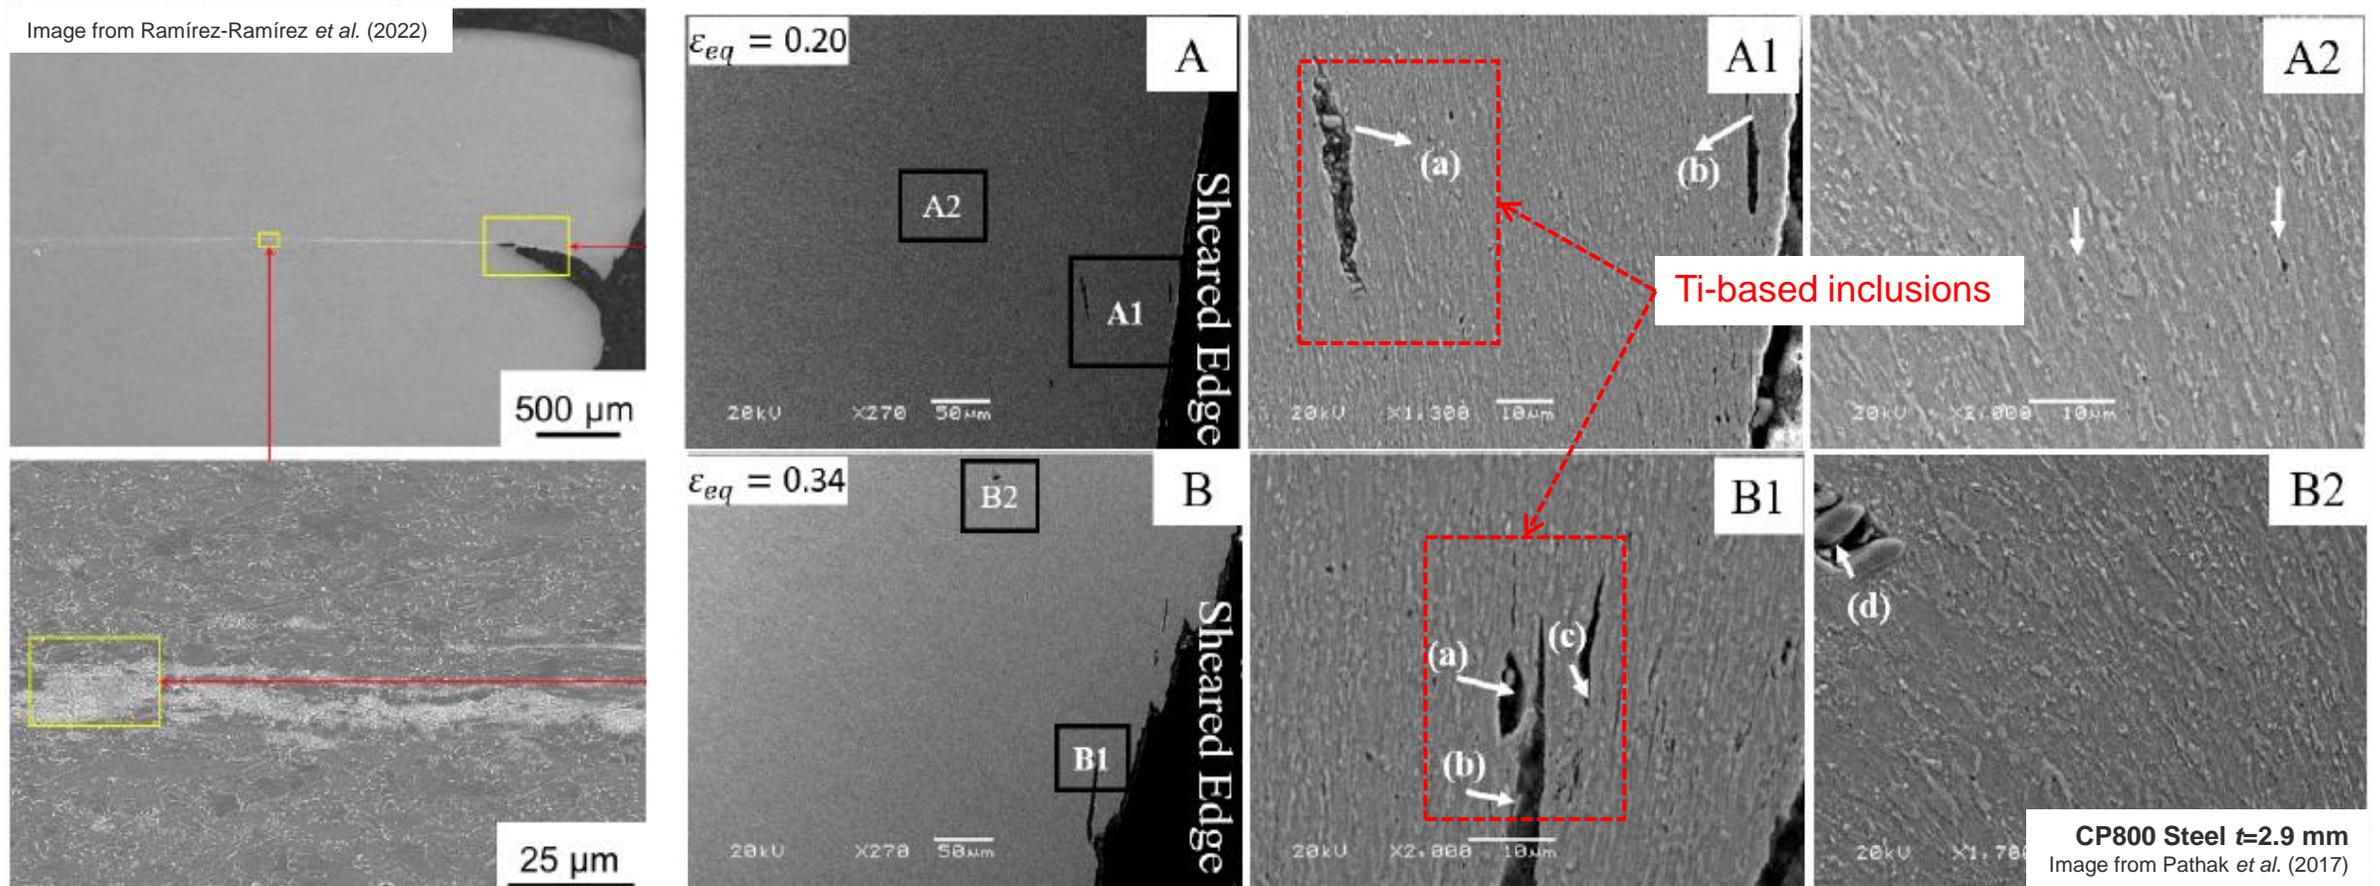
# Susceptibility to Cut Edge Fissures

- Presence of centerline segregation can trigger fissures during the shear cutting process.
- Ti-based inclusions can also act as source of cracks during stretching of the sheared edge...

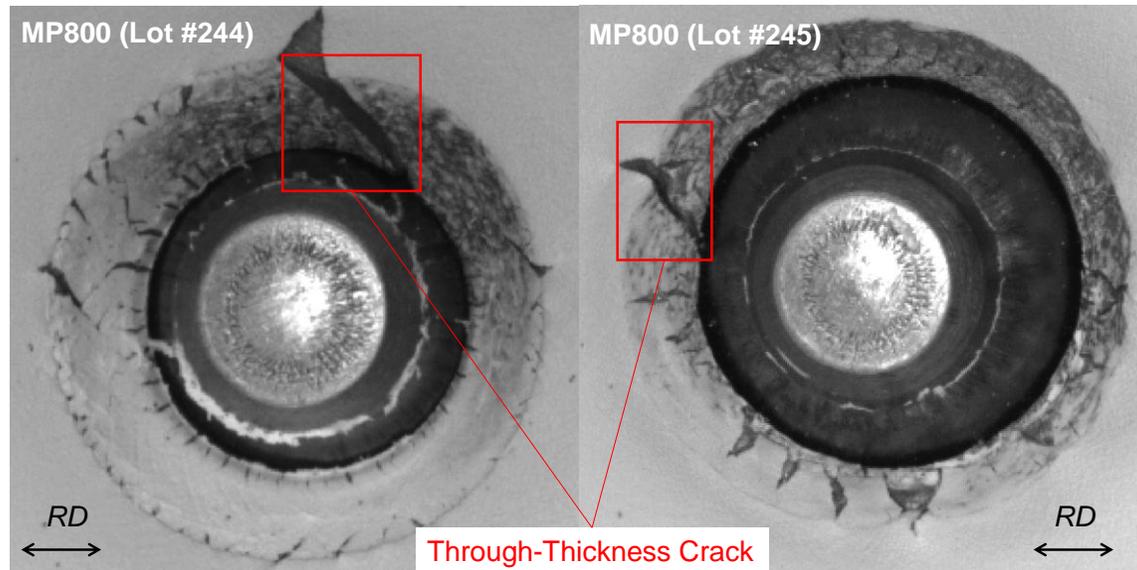
Conical HX (12% CI) –Insight into Cut Edge Fissure Susceptibility?

- Centerline segregation detection requires spectroscopy or etching and optical imaging → time and cost intensive.
- **Can sheared edge stretching behaviour correlate to cut edge fissure susceptibility in steel coils?**
- Conical hole expansion is standardized. Alternate tests deform the centerline and shear affected zone in different modes.

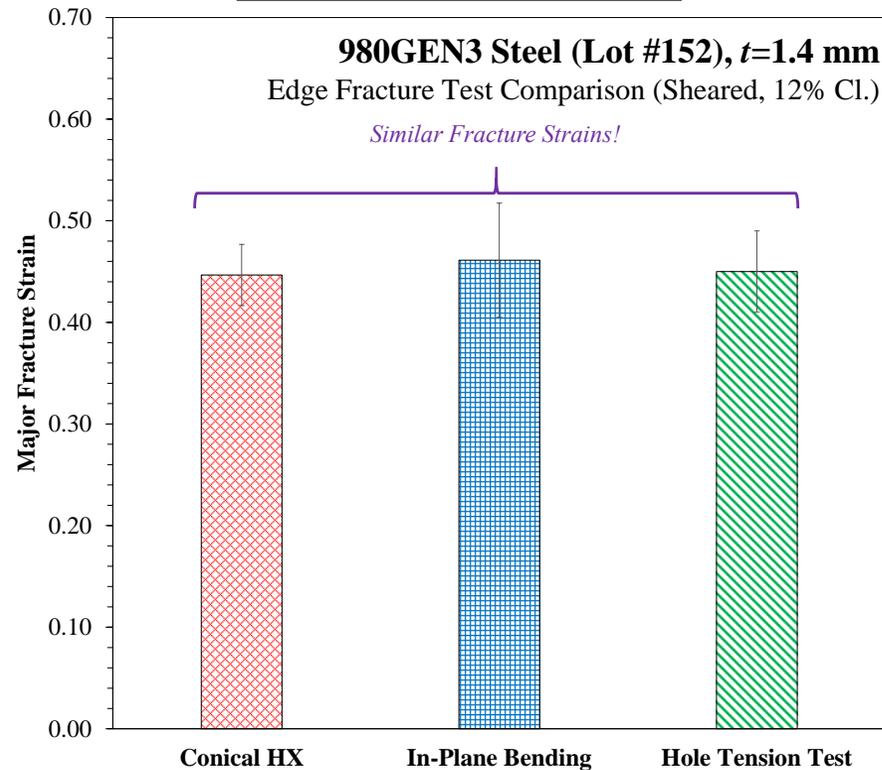
980GEN3 Fracture Strains (12% Cl.)

- Recap: Previous work conducted on 980GEN3 steel revealed minimal edge sensitivity to boundary condition at 12% clearance.
- **However, fracture limits can diverge between the tests for hot-rolled MP800 steels due to centerline effects.**
- Conical HX → *Centerline crack propagation can be delayed due to punch contact.* In-plane Bending → *centerline in uniaxial tension.*

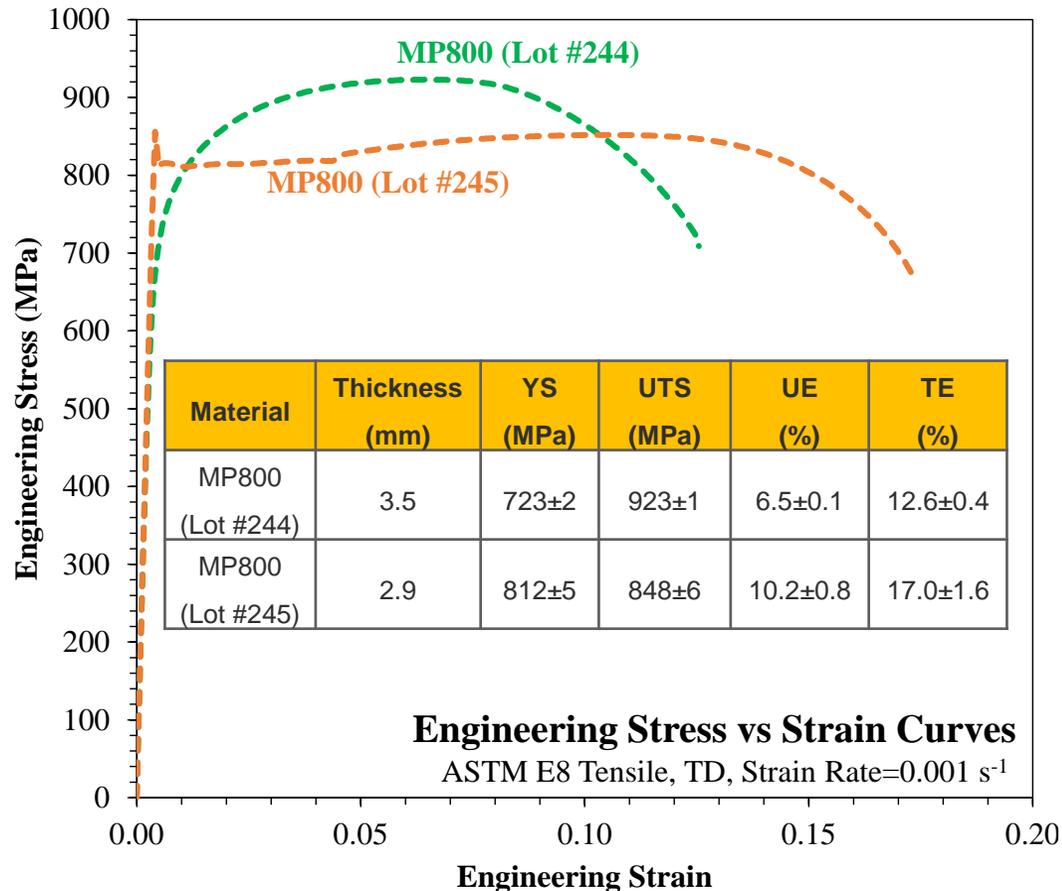
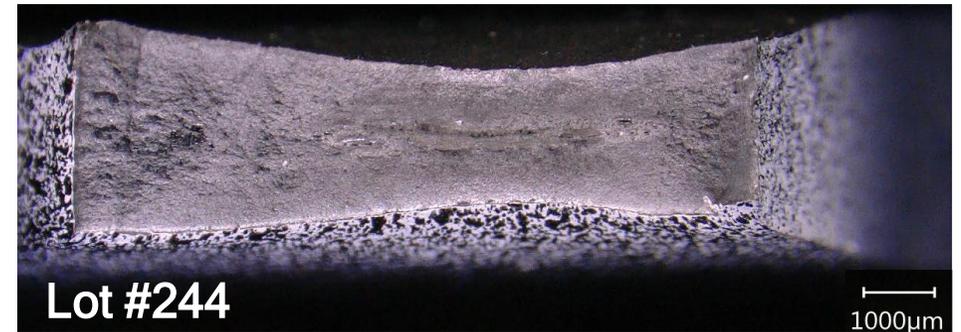
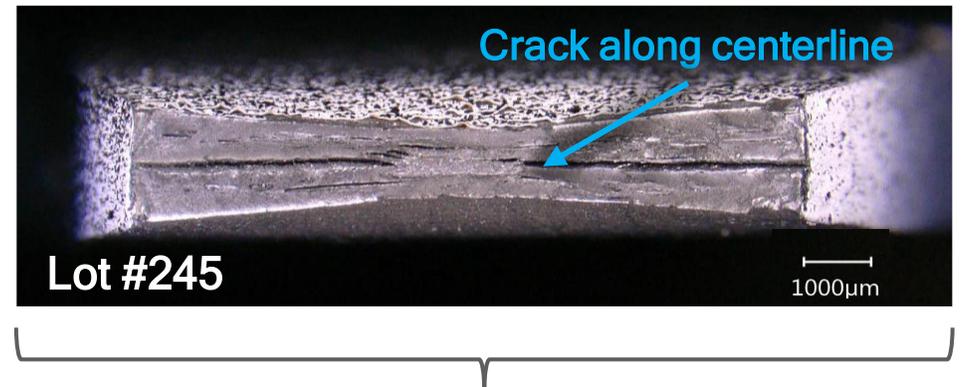
- Two lots of MP800 steels considered. Lot #245 has higher elongation and a lower hardening rate than Lot #244.
- Higher cut edge fissure susceptibility in Lot #245 → centerline cracks observed in ruptured tensile specimens.

Lot #245 tensile fracture surface can correlate to edge fissure susceptibility during shearing

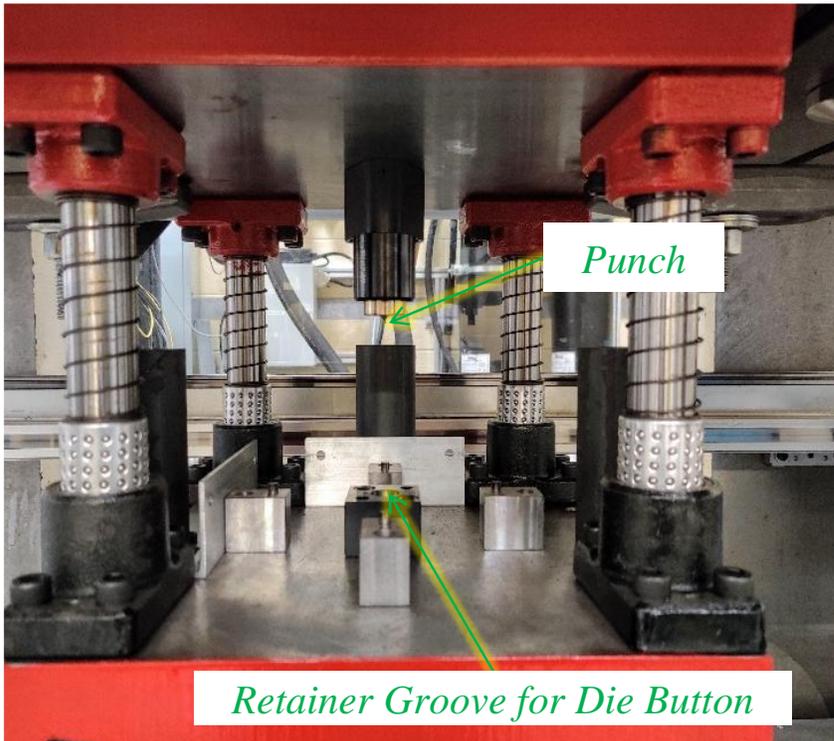
Hole Punching Tool

- Four clearances considered : 5%, 8%, 12%, and 20%. Hole size of 5 mm (circle or square).
- Edge profile dominated by burnish & fracture zones. Minimal rollover and burr.

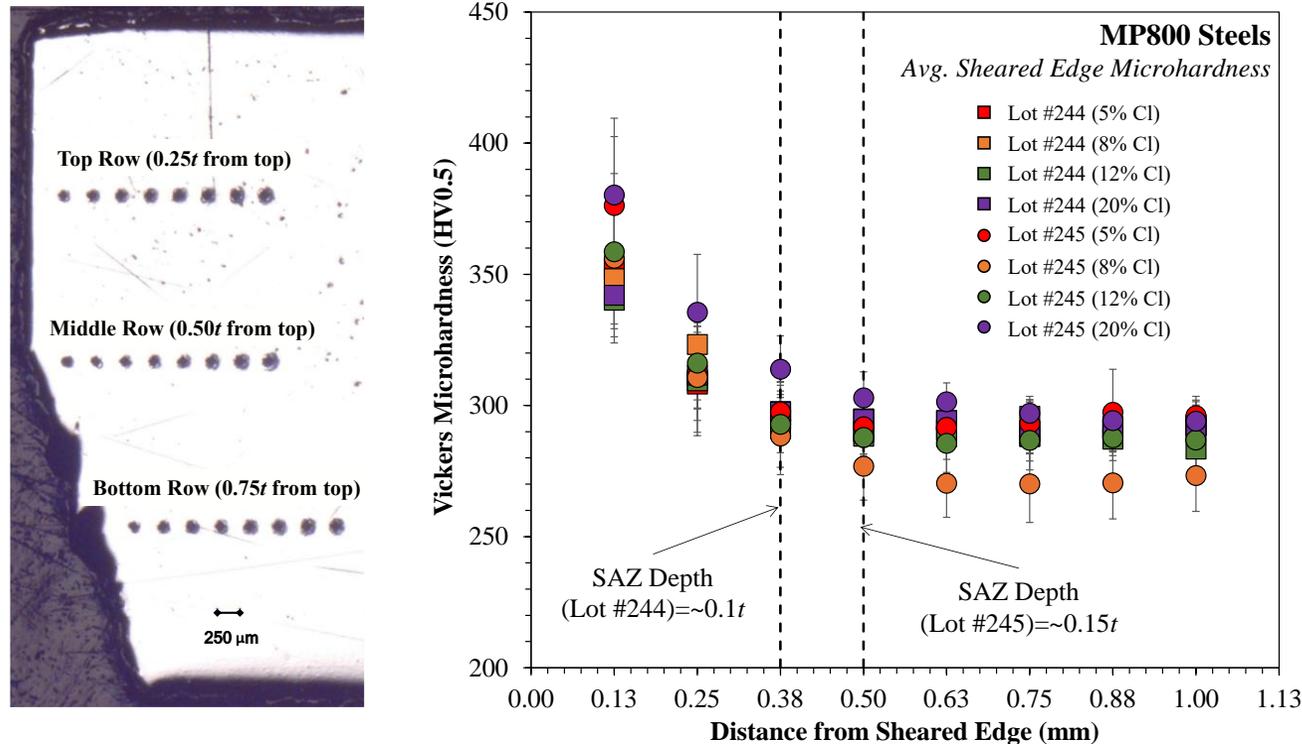
Variation of Avg. Hardness with Distance from Sheared Edge

- Average hardness of SAZ statistically similar for the two MP800 steels across all clearances.
- **Presence of Ti-based inclusions near mid-thickness observed for Lot #245 after etching.**

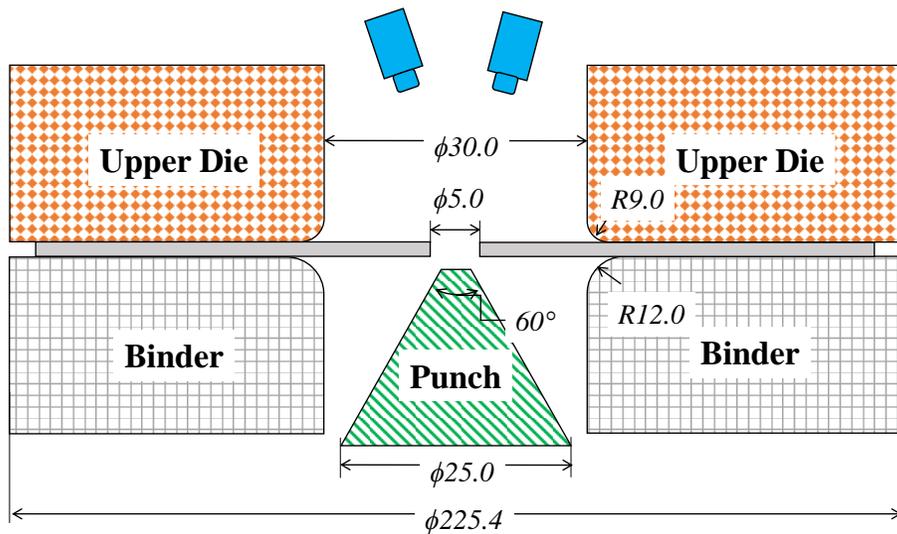
Conical Hole Expansion Setup

- Standardized sheared edge stretching test. Hole diameter of 5.0 mm adopted to reduce chances of necking.
- Test can be monitored continuously using cameras to analyze through-thickness crack image post failure.
- **Major fracture strain can be obtained from outer hole geometry without need for DIC!**

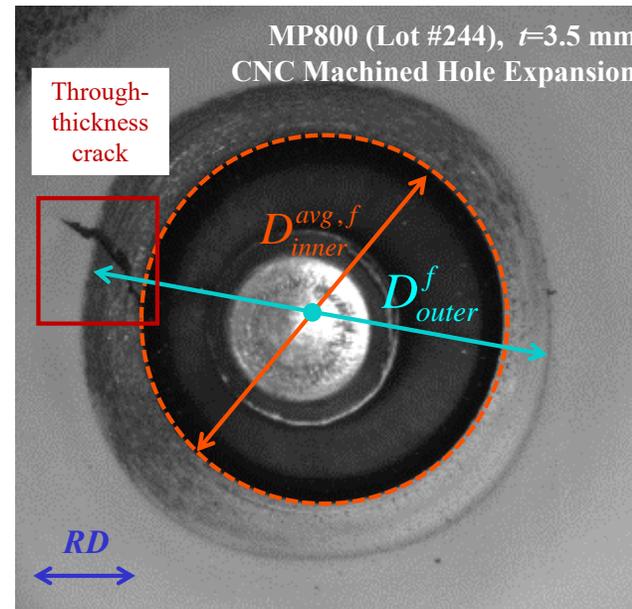
Measurements from Conical HX

➔ **Hole expansion ratio:**

$$HER(\%) = \left( \frac{D_{inner}^{avg,f} - D_0}{D_0} \right) \times 100$$

➔ **Major fracture strain:**

$$\epsilon_1^{HX} = \ln \left( \frac{D_{outer}^f}{D_0} \right)$$

➔ **Initial Diameter:**  $D_0 = 5.0 \text{ mm}$

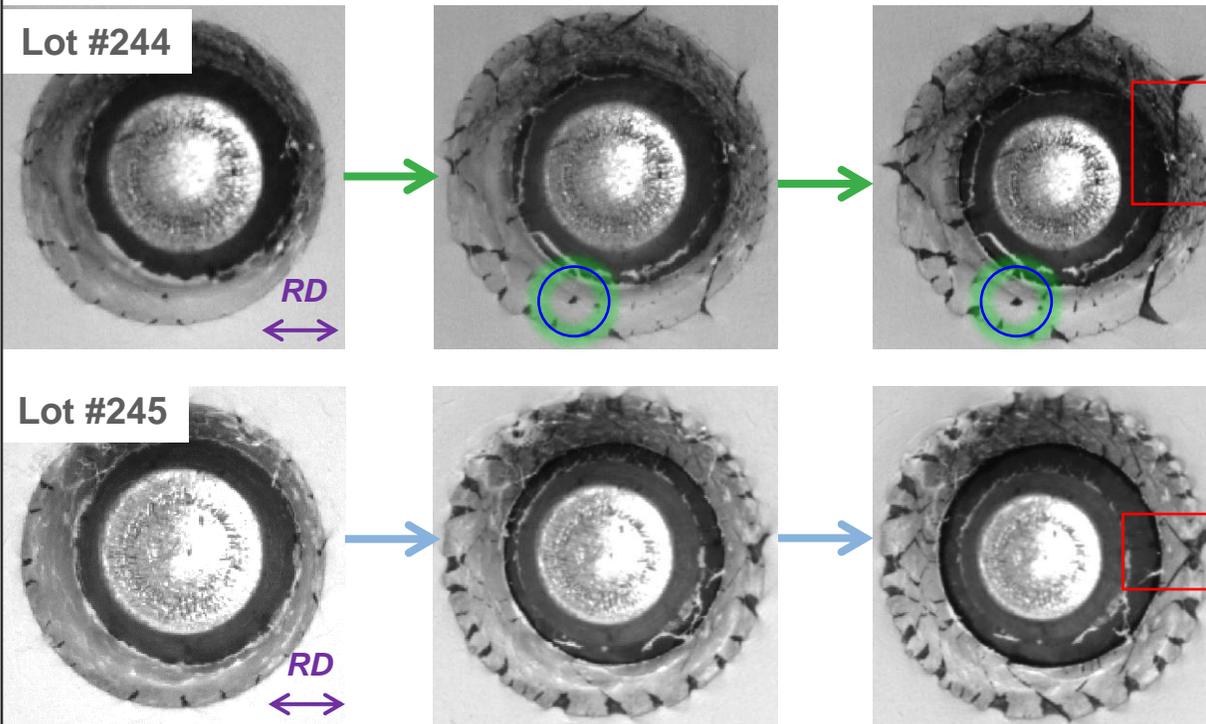
Conical HX Crack Progression (5% Clearance)

- Few cracks can be observed at mid-thickness for 5% clearance for Lot #244 having lower edge fissure susceptibility.
- Cracks primarily initiated from the edges to then propagate through-thickness at 5% and 8% clearances for Lot #245.

Crack at centerline/mid-thickness

Through-thickness Crack

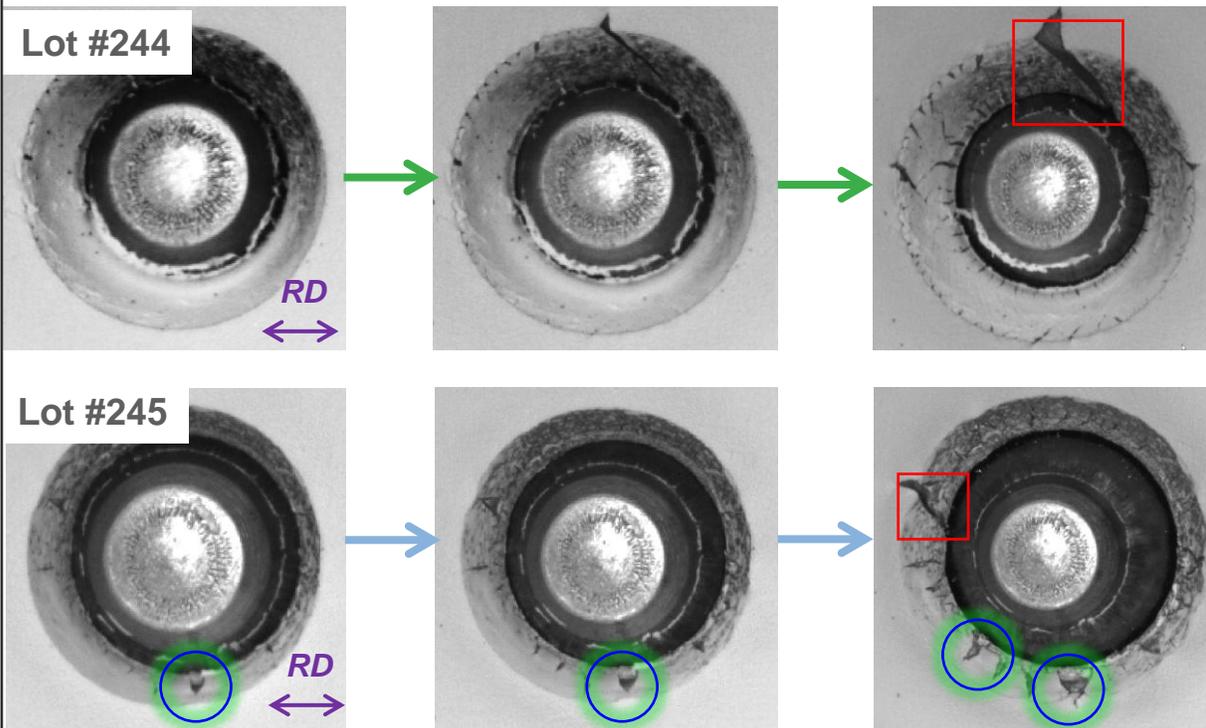
Conical HX Crack Progression (12% Clearance)

- Several centerline cracks observed in Lot #245 during conical HX of holes punched at 12% and 20% clearances.
- No mid-thickness cracks observed during conical HX of punched Lot #244 samples except at 5% clearance.

Crack at centerline/mid-thickness

Through-thickness Crack

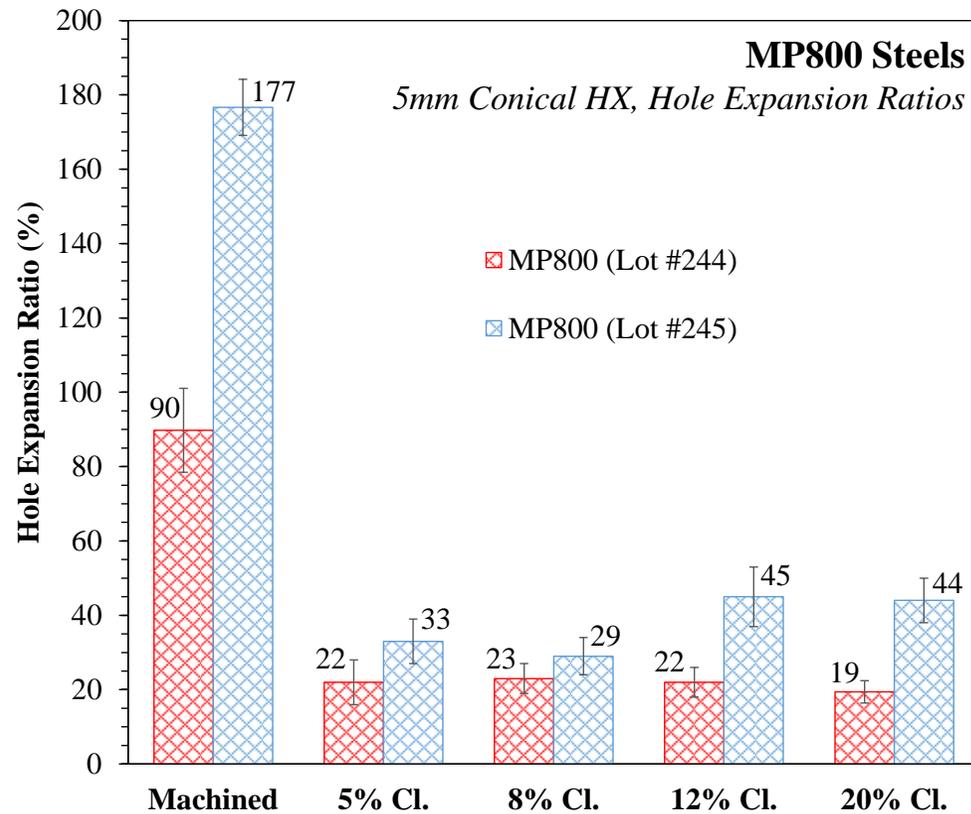
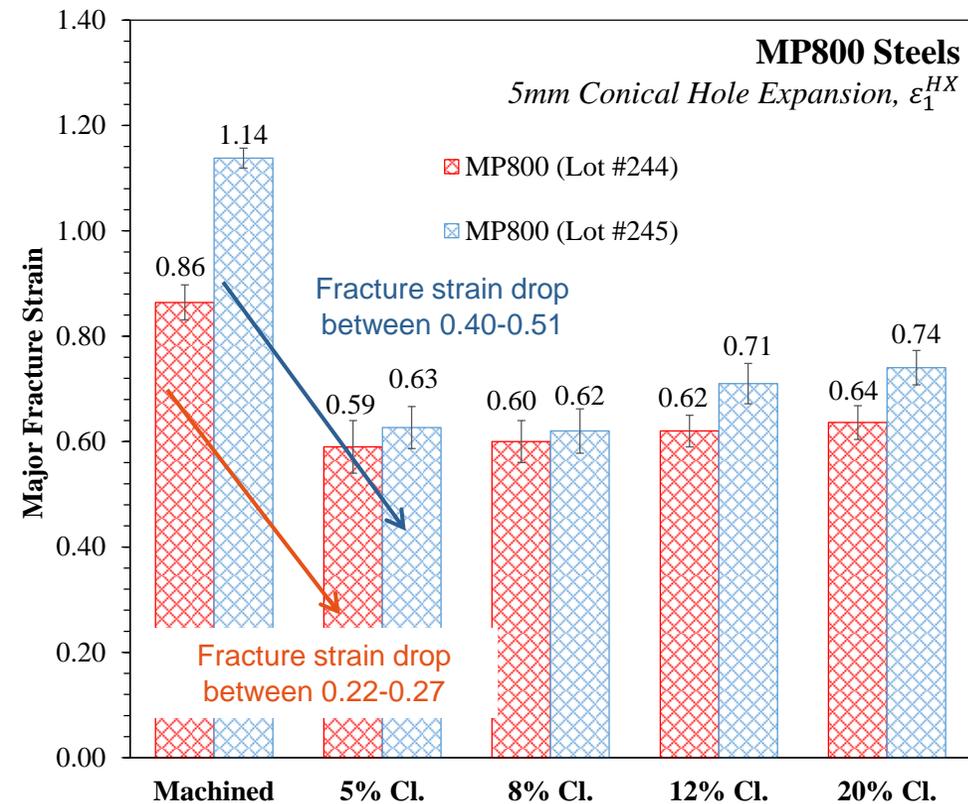
- Higher delta in HER and fracture strain observed after shearing for Lot #245.
- Negligible clearance effect for Lot #244. Lot #245 has highest fracture strains for 12% and 20% clearances.

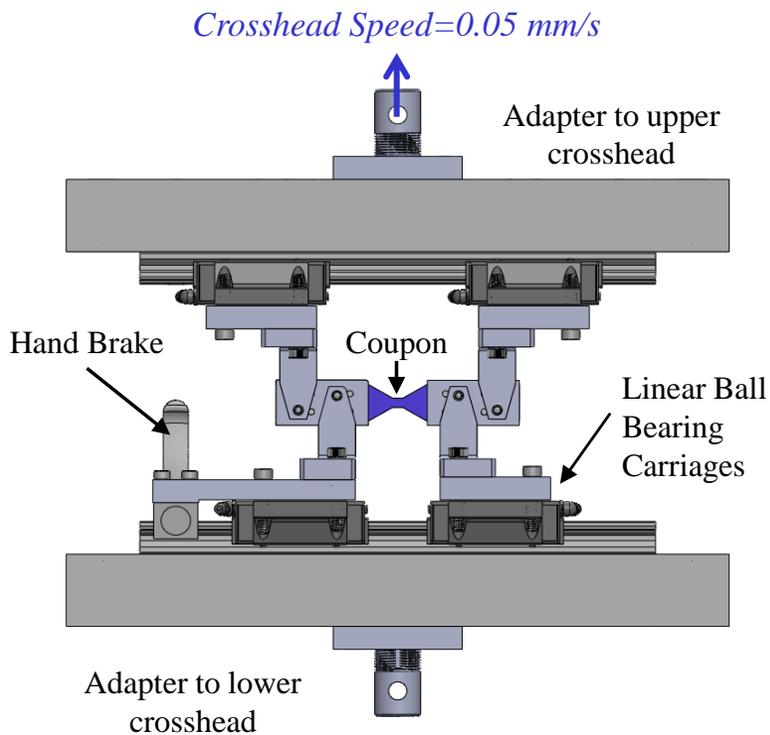
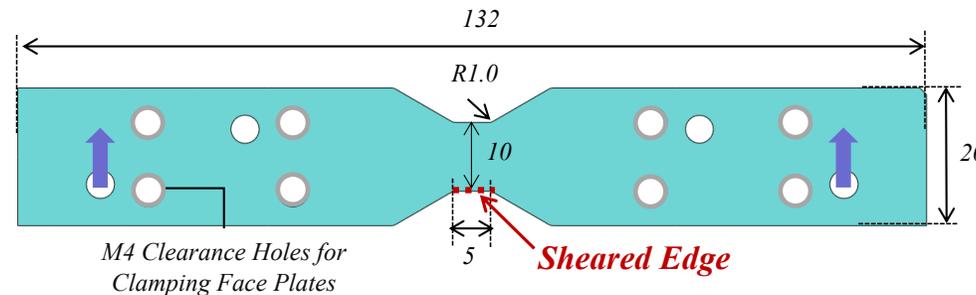
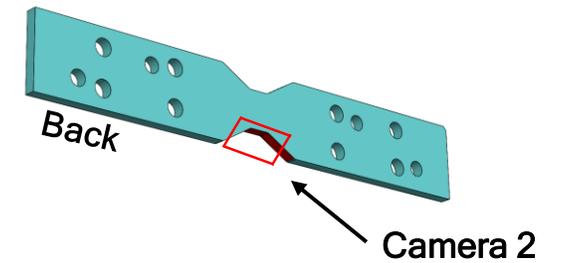
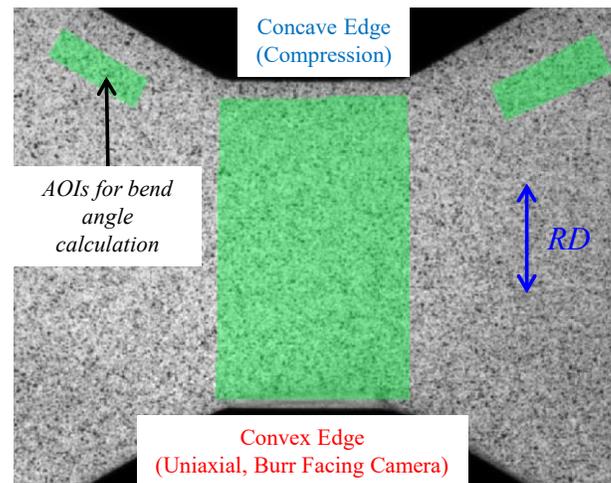
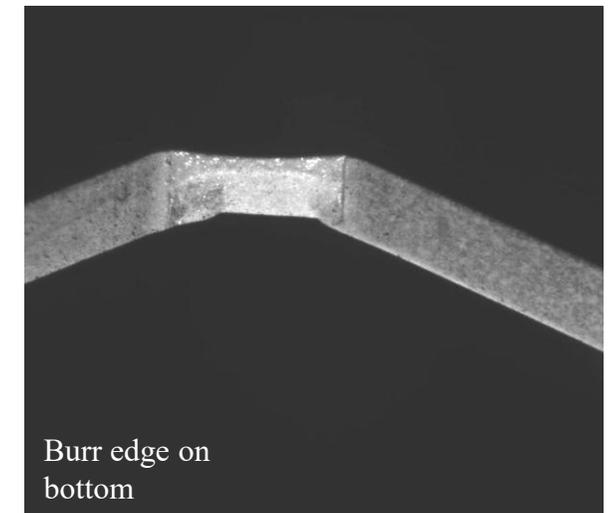
- Fixture installed on a Shimadzu AGS-X tensile frame with 10 kN load capacity. Principal stretching in TD.
- Gauge section dimensions of the specimen chosen to prevent out-of-plane buckling during deformation.
- Sheared edge placed on convex side under tension. A 2<sup>nd</sup> camera was placed underneath to monitor crack propagation.

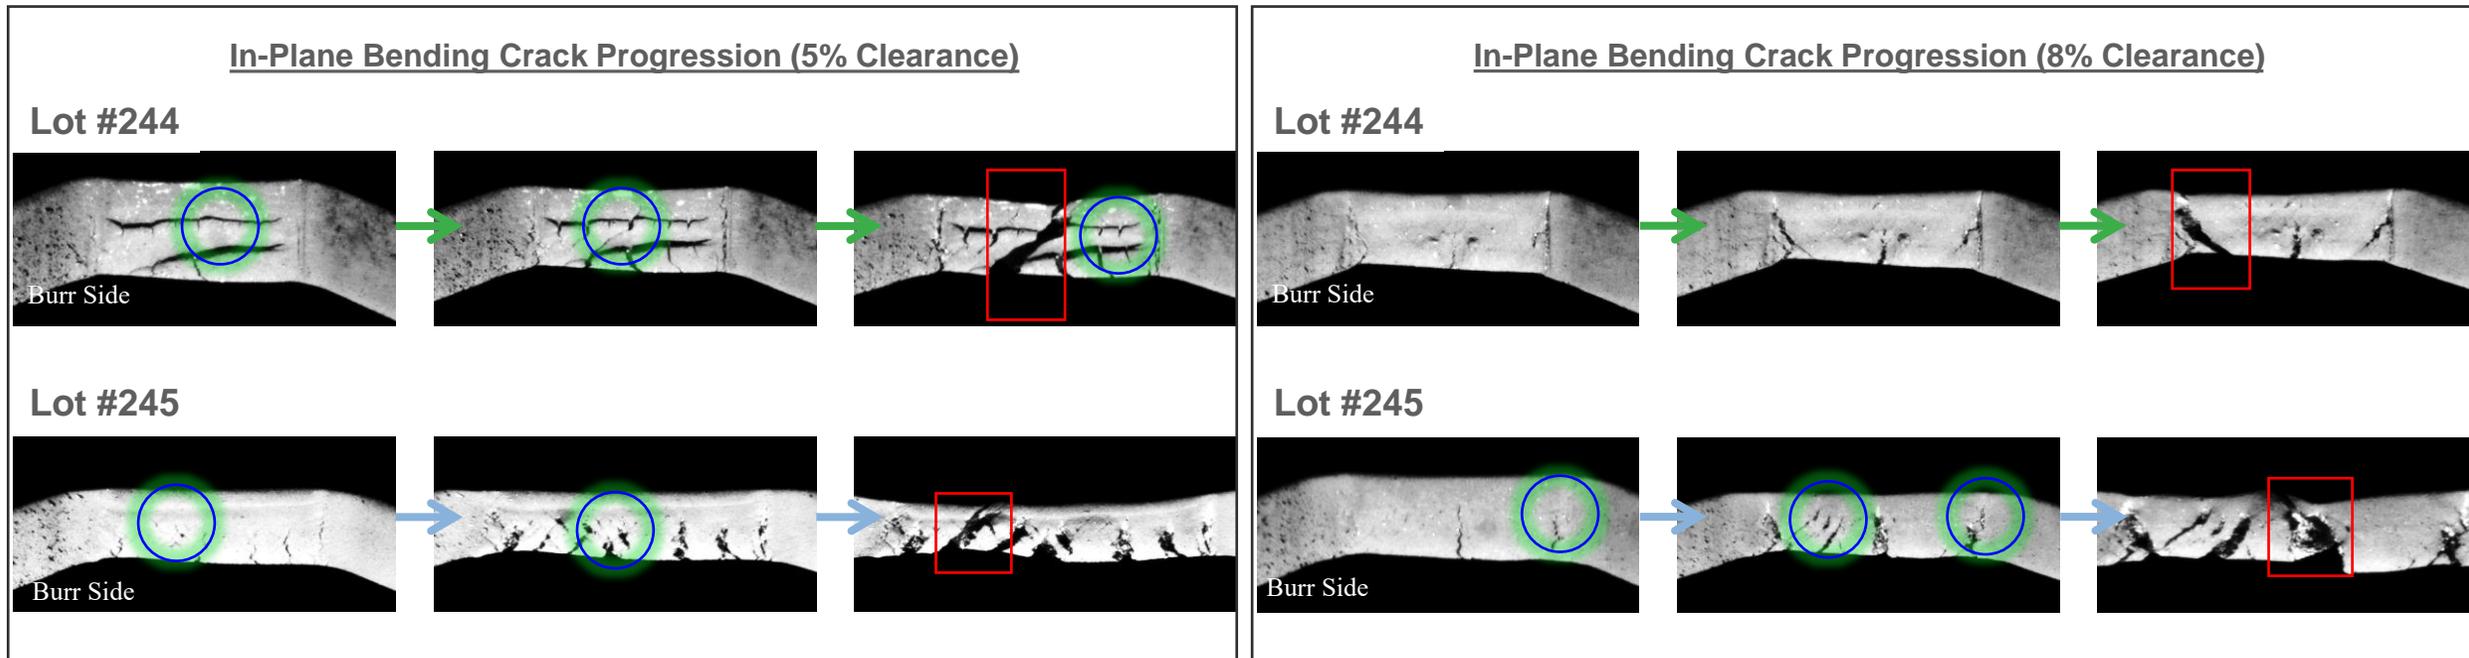
- Centerline crack occurrence in Lot #244 at 5% clearance → consistent with conical HX observations.
- Cracks initiate from the burr side for Lot #244 in-plane bend test conducted with 8% clearance.
- Few centerline microcracks observed for Lot #245 as well at both 5% and 8% clearances.

Crack at centerline/mid-thickness

Through-thickness Crack

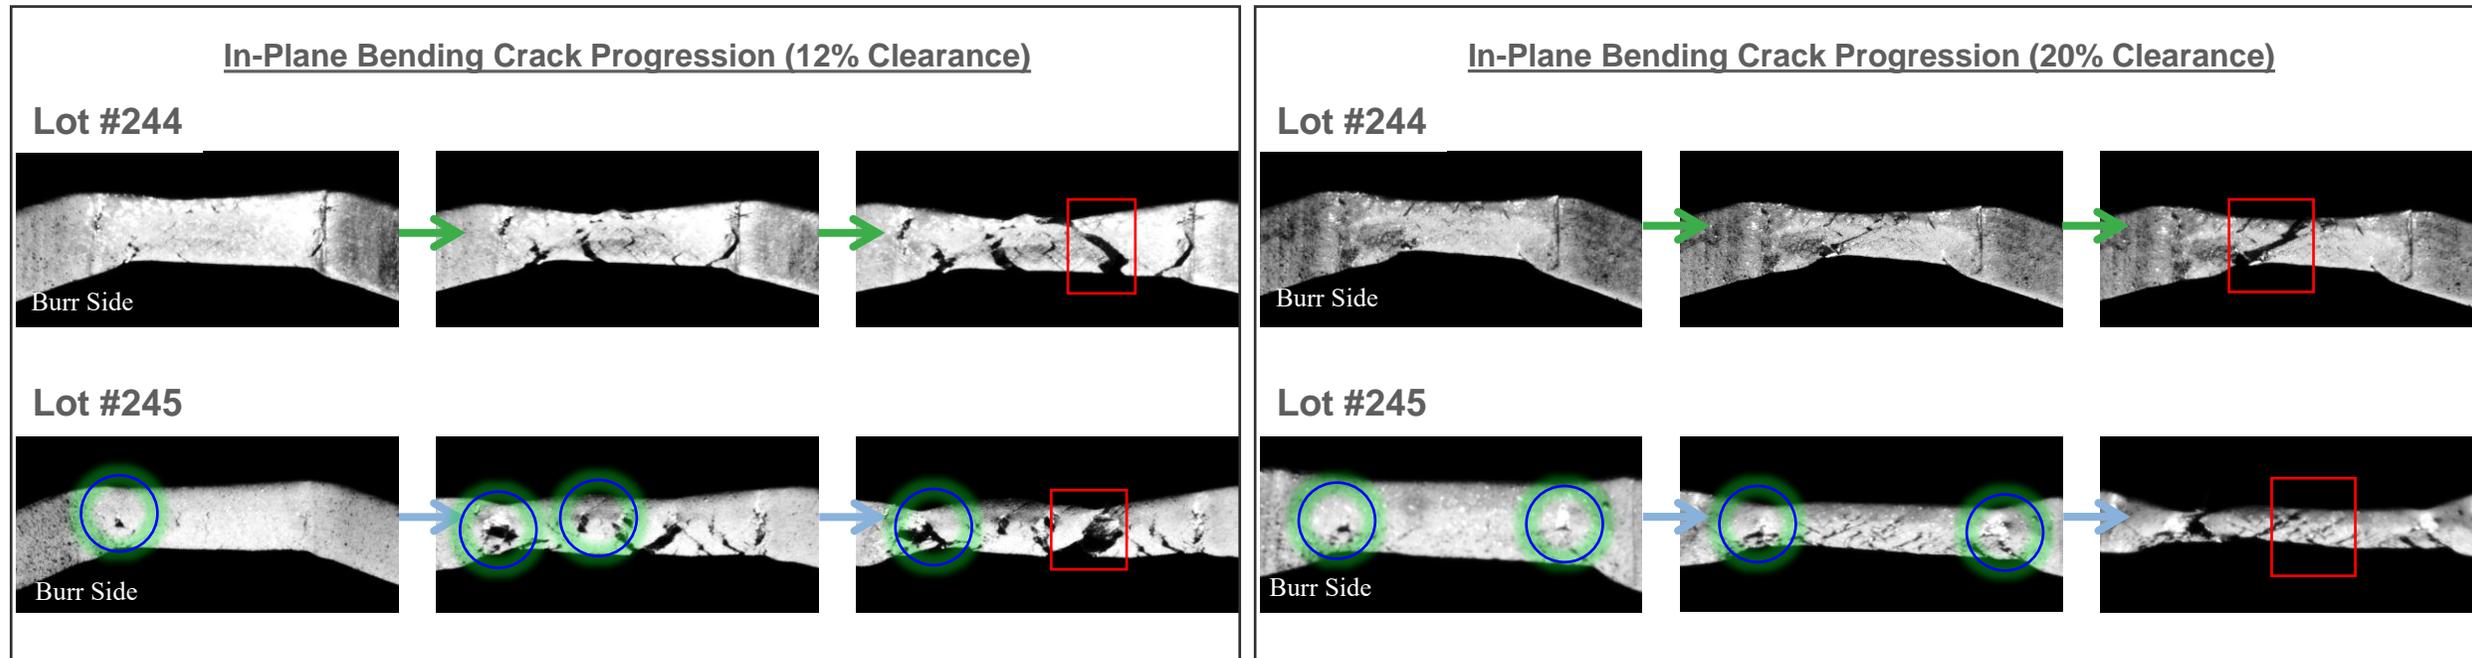
- Cracks initiated on the burr side in Lot #244 bend tests at 12% and 20% cl.
- Numerous cracks develop at centerline for 12% and 20% clearances for Lot #245.

Crack at centerline/mid-thickness

Through-thickness Crack

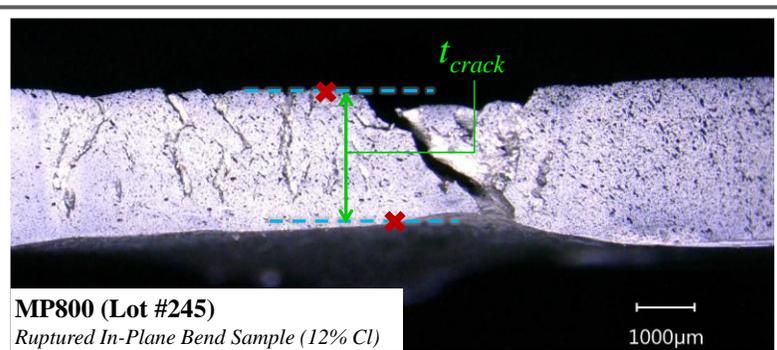
Fracture Strain from Post-Mortem Thickness

MP800 (Lot #245)  
Ruptured In-Plane Bend Sample (12% CI)

$$\epsilon_3^{IPB} = \ln\left(\frac{t_{crack}}{t_0}\right); \epsilon_1^{IPB} = -(1 + R_{90}) \times \epsilon_3^{IPB}$$

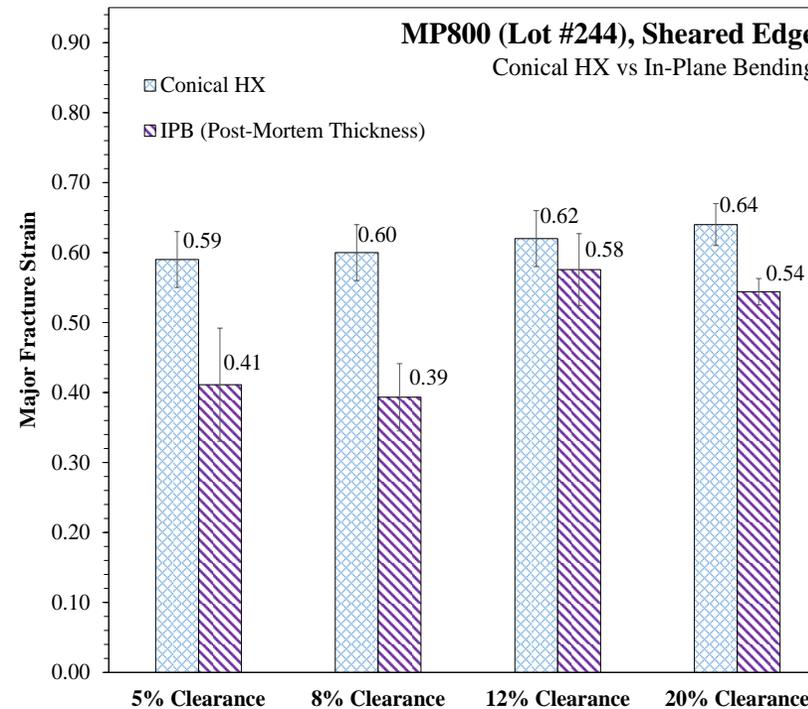
MP800 (Lot #244) Fracture Strains

- Post-rupture thickness was converted to fracture strain to correspond to similar fracture instant as conical HX.
- Strong boundary condition effect observed for Lot #244 at 5% and 8%. Reduced sensitivity at higher clearances.
- Marginal influence of applied loading on fracture strains for Lot #245 at all clearances except 8%.

$$R_{90}(\text{MP800 Lot \#244}) = 0.76$$

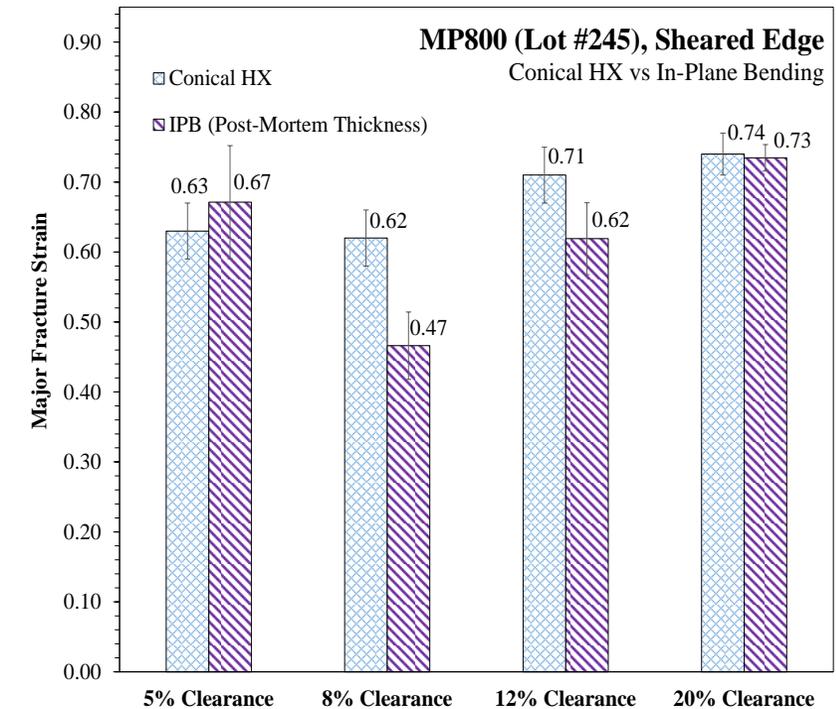
MP800 (Lot #245) Fracture Strains

$$R_{90}(\text{MP800 Lot \#245}) = 0.80$$

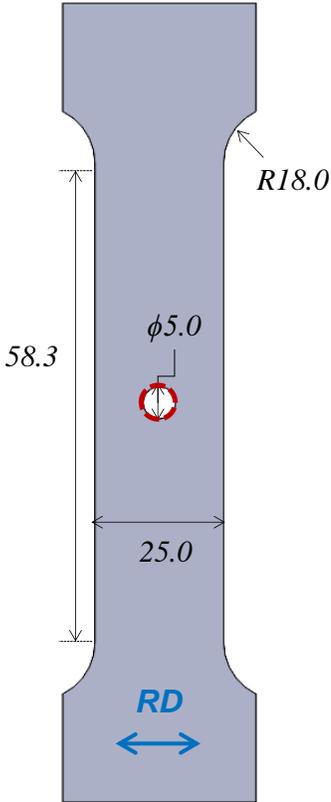
Hole Tension Geometry

- Unidirectional stretching of the hole. Tests conducted at 12% clearance since centerline cracks were seen in Lot #245.
- Cracks appear to initiate near the mid-thickness for both materials followed by gradual propagation.

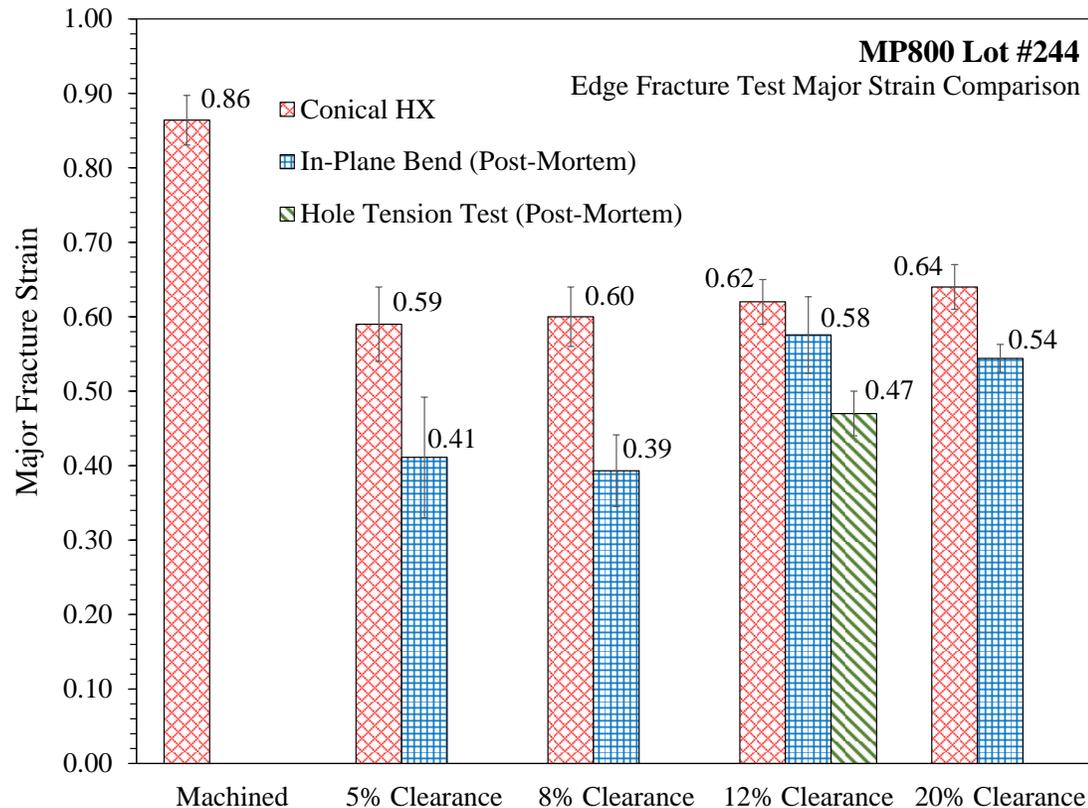
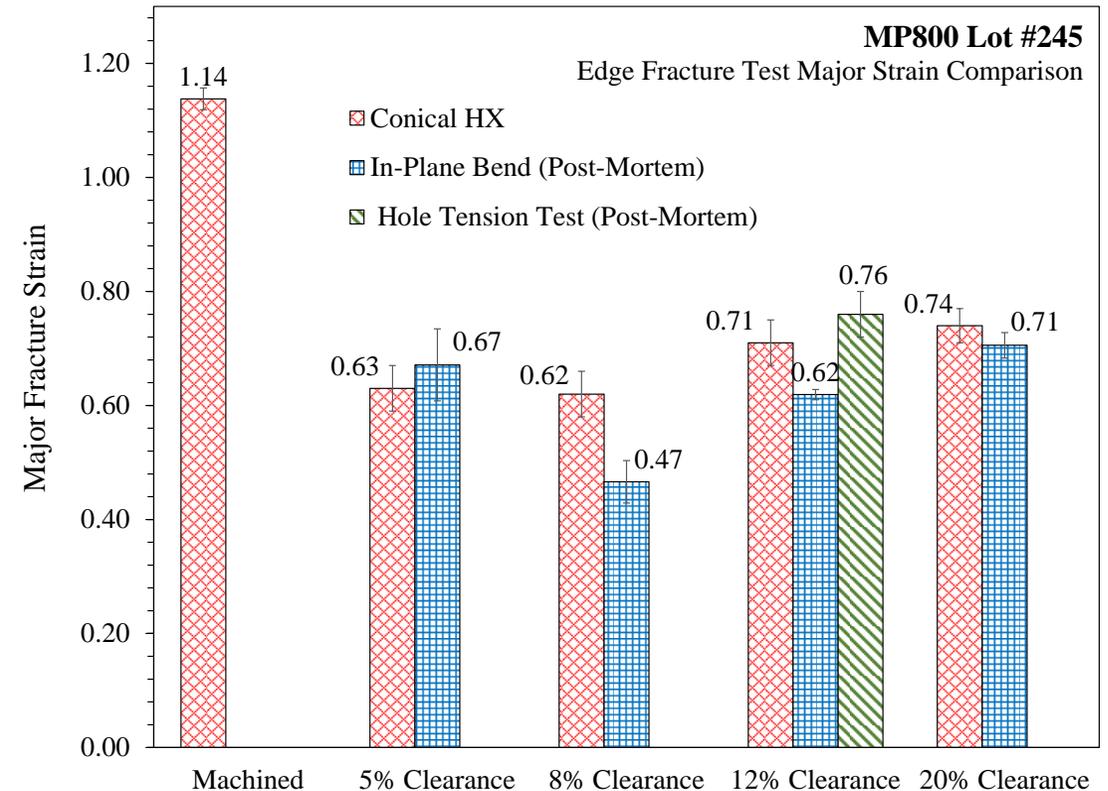
- HTT fracture strains also measured using post-mortem thickness. Tests compared at through-thickness rupture.
- Hole tension fracture strains similar to conical HX and in-plane bending for Lot #245.
- **Significant sensitivity to test type observed for Lot #244 at 12% clearance. Strong boundary condition effect!**

- Tensile fracture surface and stretching of edges sheared at 12% or higher promoted centerline cracks in Lot #245.
- Lot #245 possessed similar or higher fracture strain than Lot #244 due to its larger elongation and low hardening rate.
- **Strong sensitivity of fracture strains to test type observed in Lot #244. Relatively smaller influence in Lot #245.**
