# Deformation & Edge Stretchability Of Multiphase Steels After Shear Cutting

**Advaith Narayanan**  
*University of Waterloo*

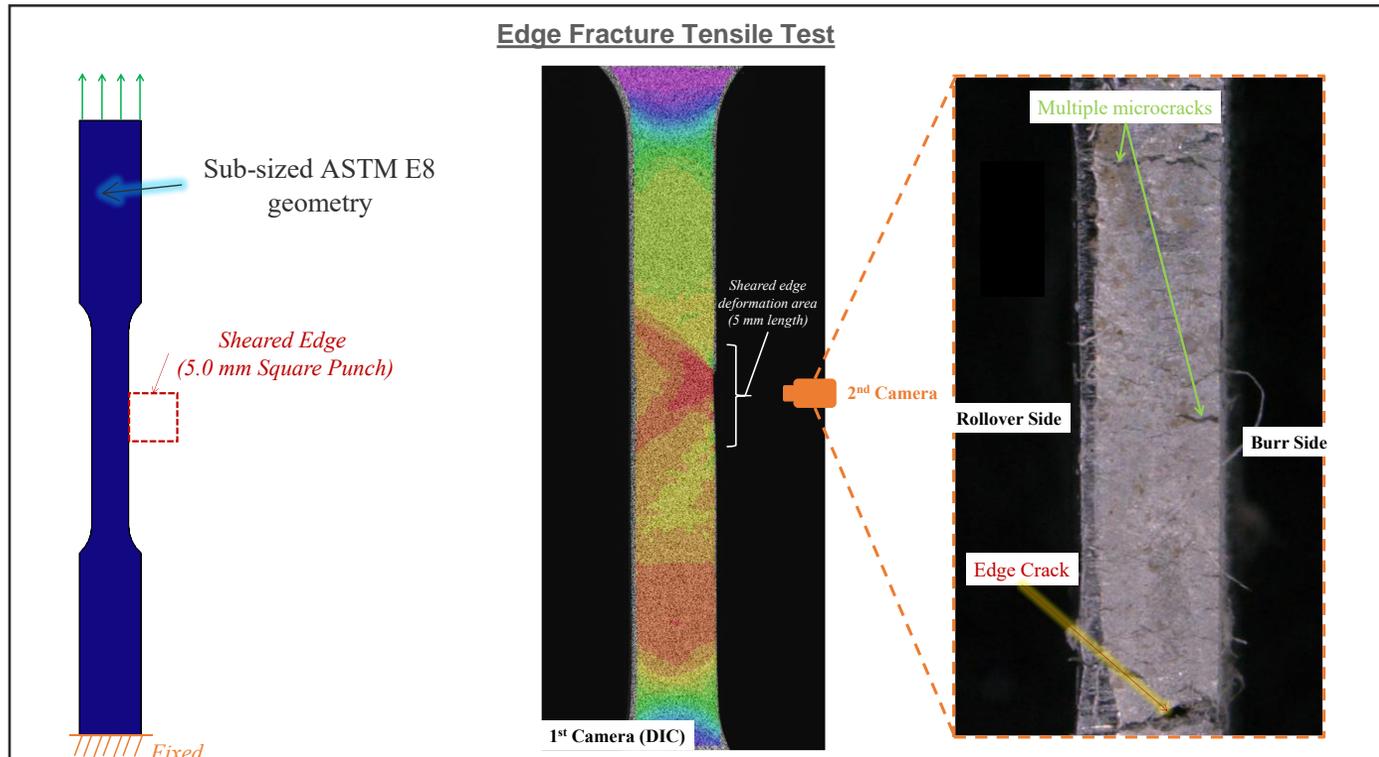
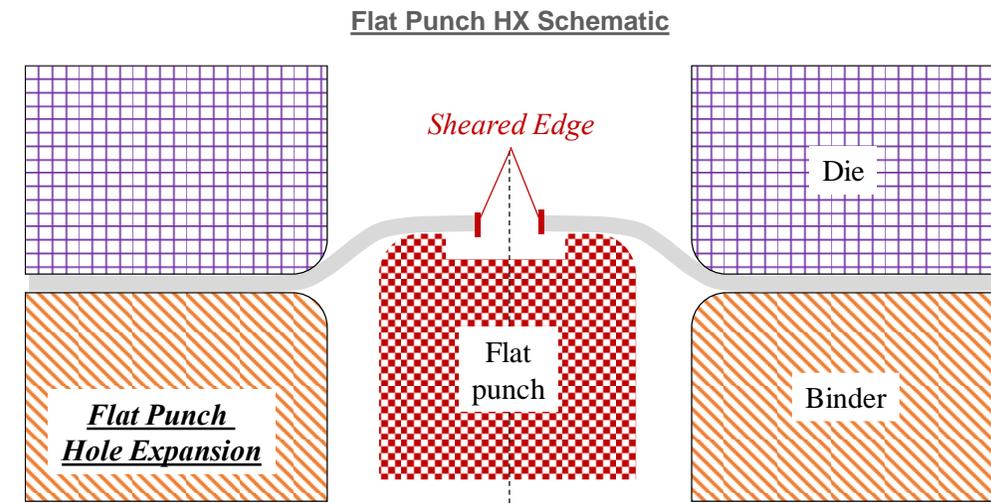
# Next Steps on MP800 Edge Stretchability

- Additional clearances such as 2%, 10%, and 30% will be considered for select edge fracture characterization tests.
- Edge fracture tensile test and flat punch HX will be conducted at clearances with lowest and highest edge formability.
- **Output: Assess influence of stress and strain gradients in the SAZ on edge fracture strain at multiple clearances.**

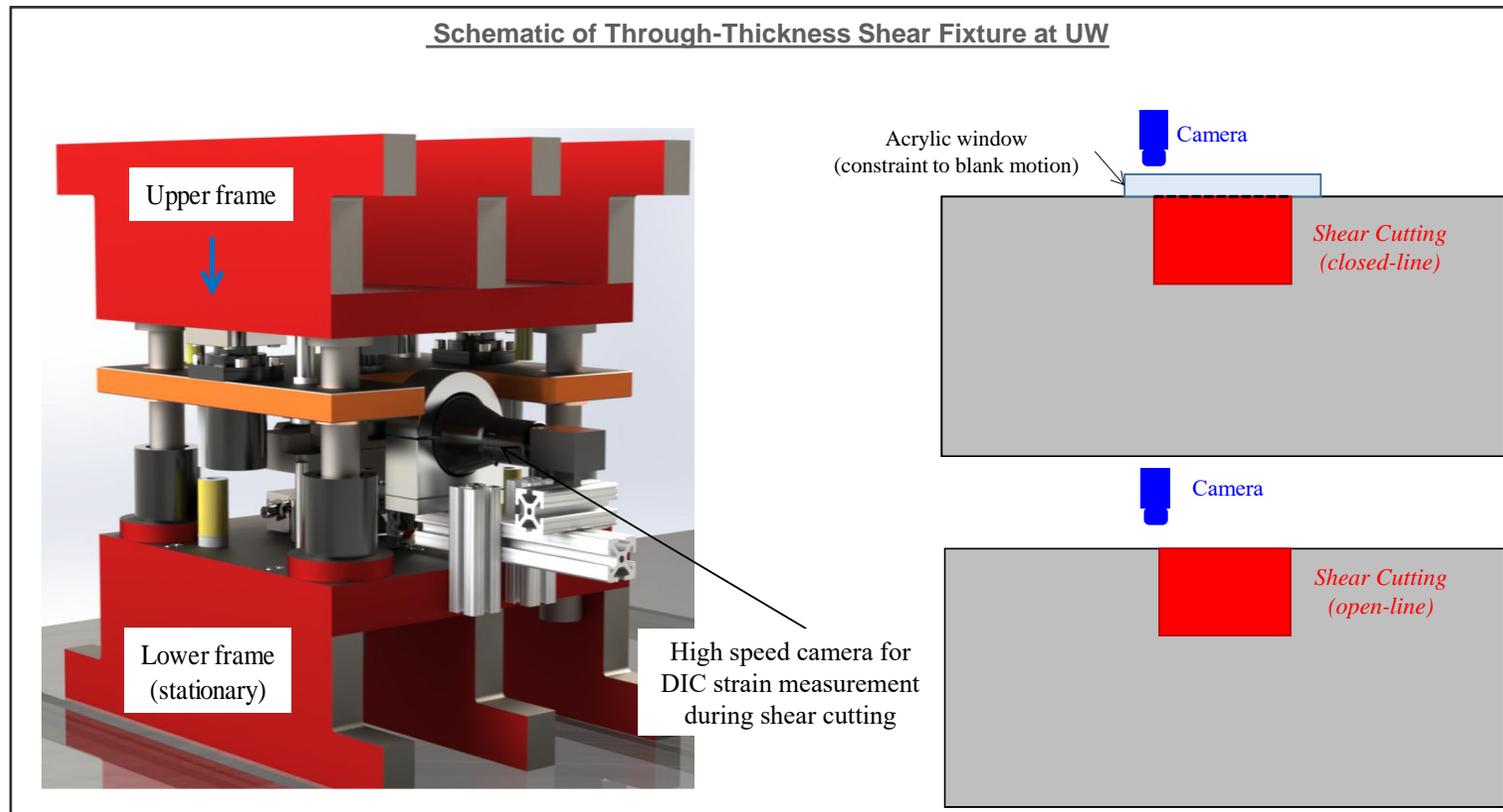
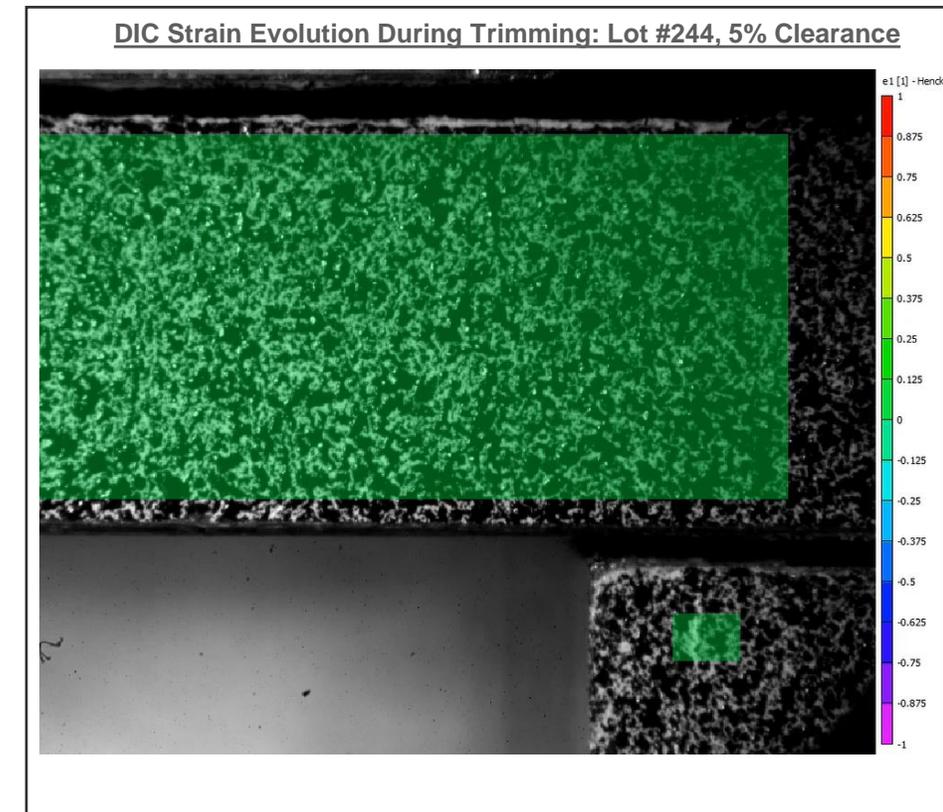
# Future Work

- Influence of trimming vs punching and tool wear on cut edge fissure generation and edge stretchability.
- Experimental measurement and numerical modelling of strains induced during shear cutting.
- SAZ mapping and evaluation of FE simulations of edge stretching using software like LS-DYNA and Autoform.

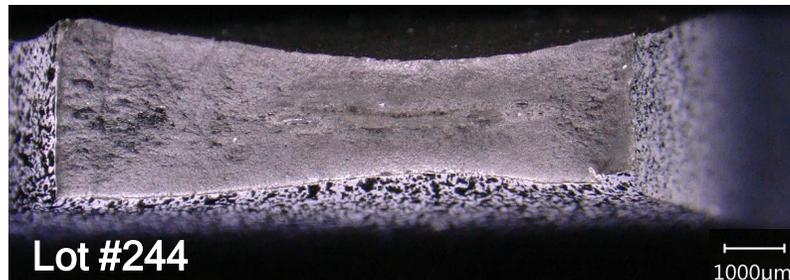
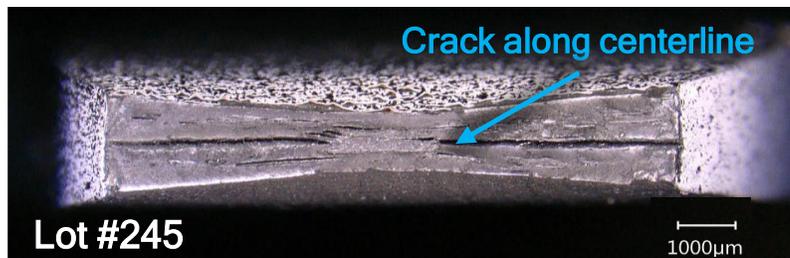
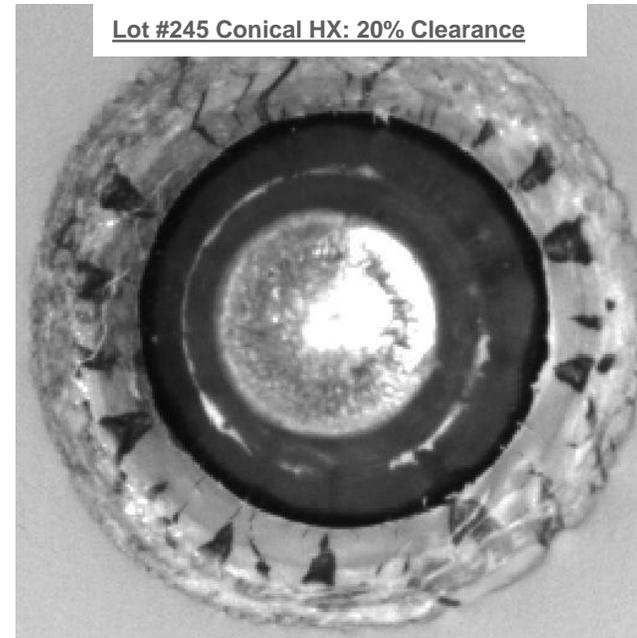
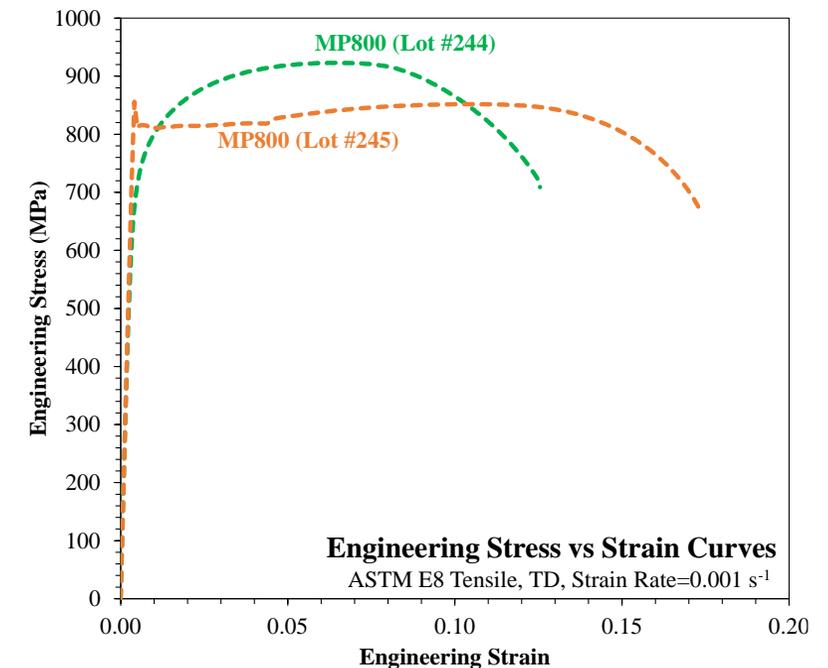
# Summary

- Tensile fracture surface and stretching of edges sheared at 12% or higher promoted centerline cracks in Lot #245.
- Lot #245 possessed similar or higher fracture strain than Lot #244 due to its larger elongation and low hardening rate.
- **Strong sensitivity of fracture strains to test type observed in Lot #244. Relatively smaller influence in Lot #245.**

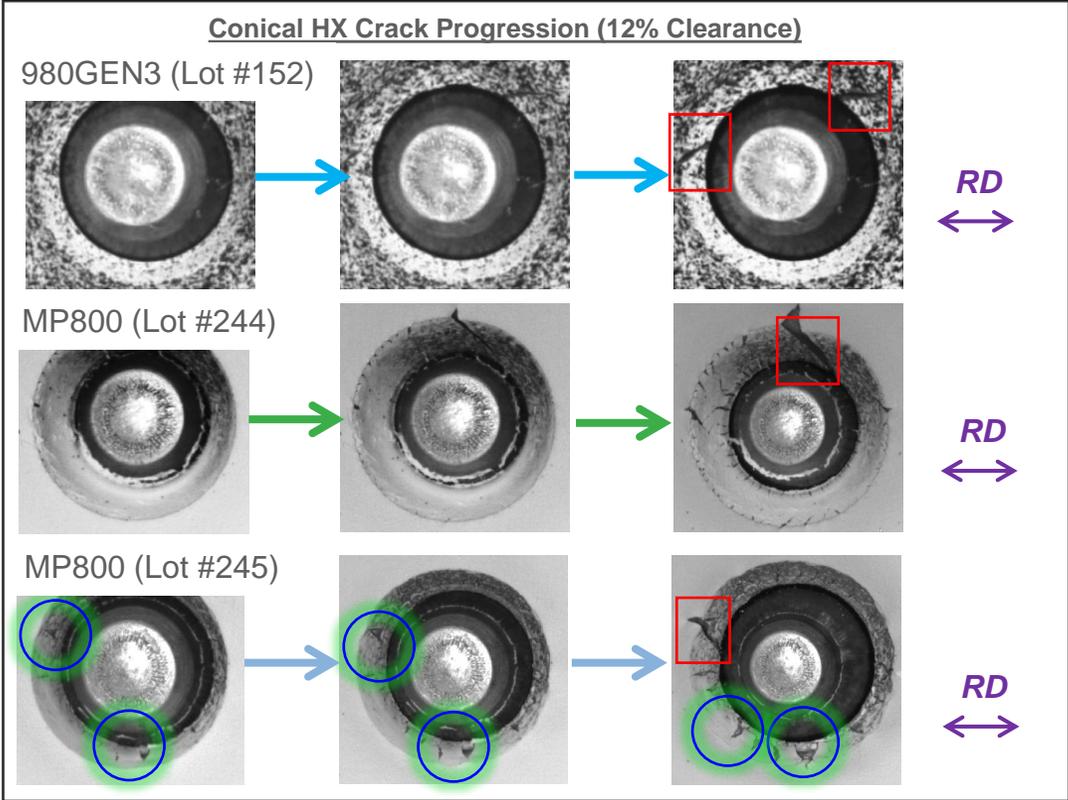
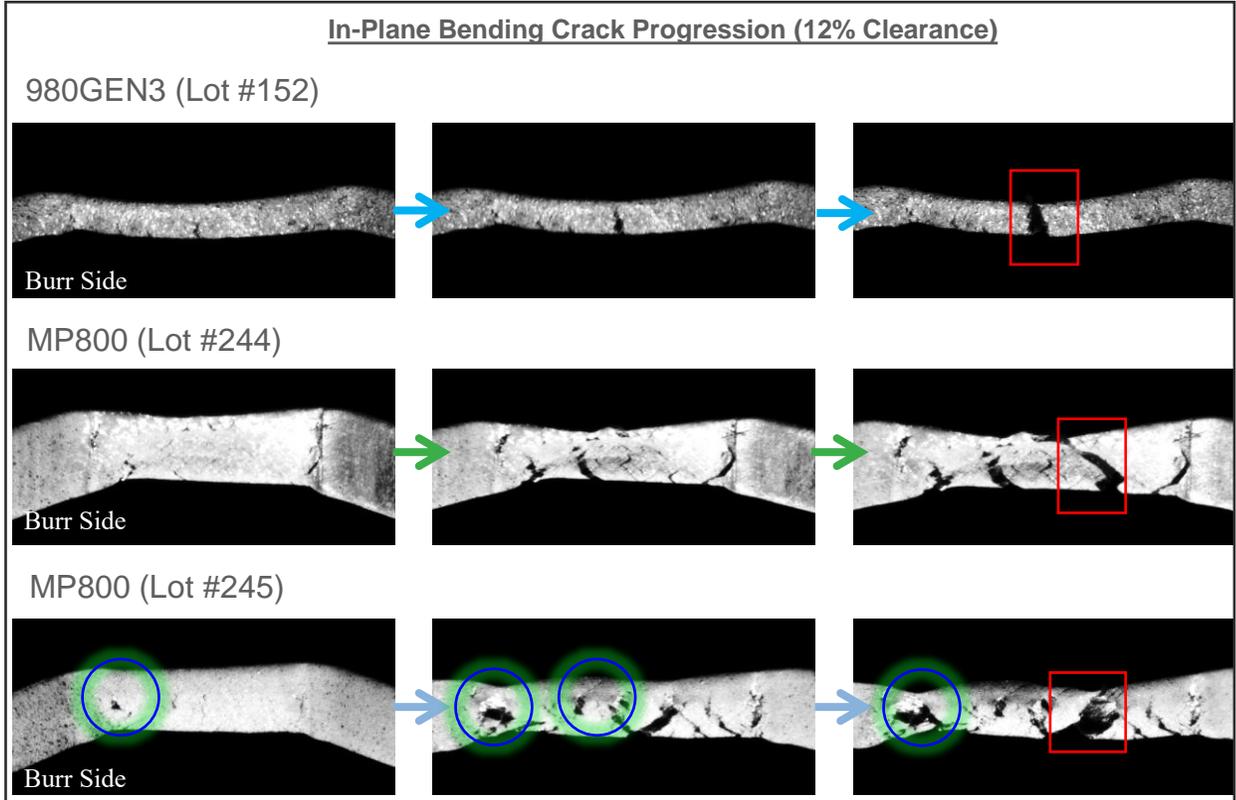
# Crack Evolution Comparison with 980GEN3 Steel

- Crack evolution behavior of the two steels contrasted with 980GEN3 having no cut edge fissure at 12% clearance.
- Cracks initiated from tensile edge observed for 980GEN3 steel regardless of the test type.

Crack at centerline/mid-thickness

Through-thickness Crack
